## Countywide Recycling & Disposal Facility

November 26, 2008

RE: Request for Information - W-57R  
Countywide Recycling and Disposal Facility, East Sparta, Ohio

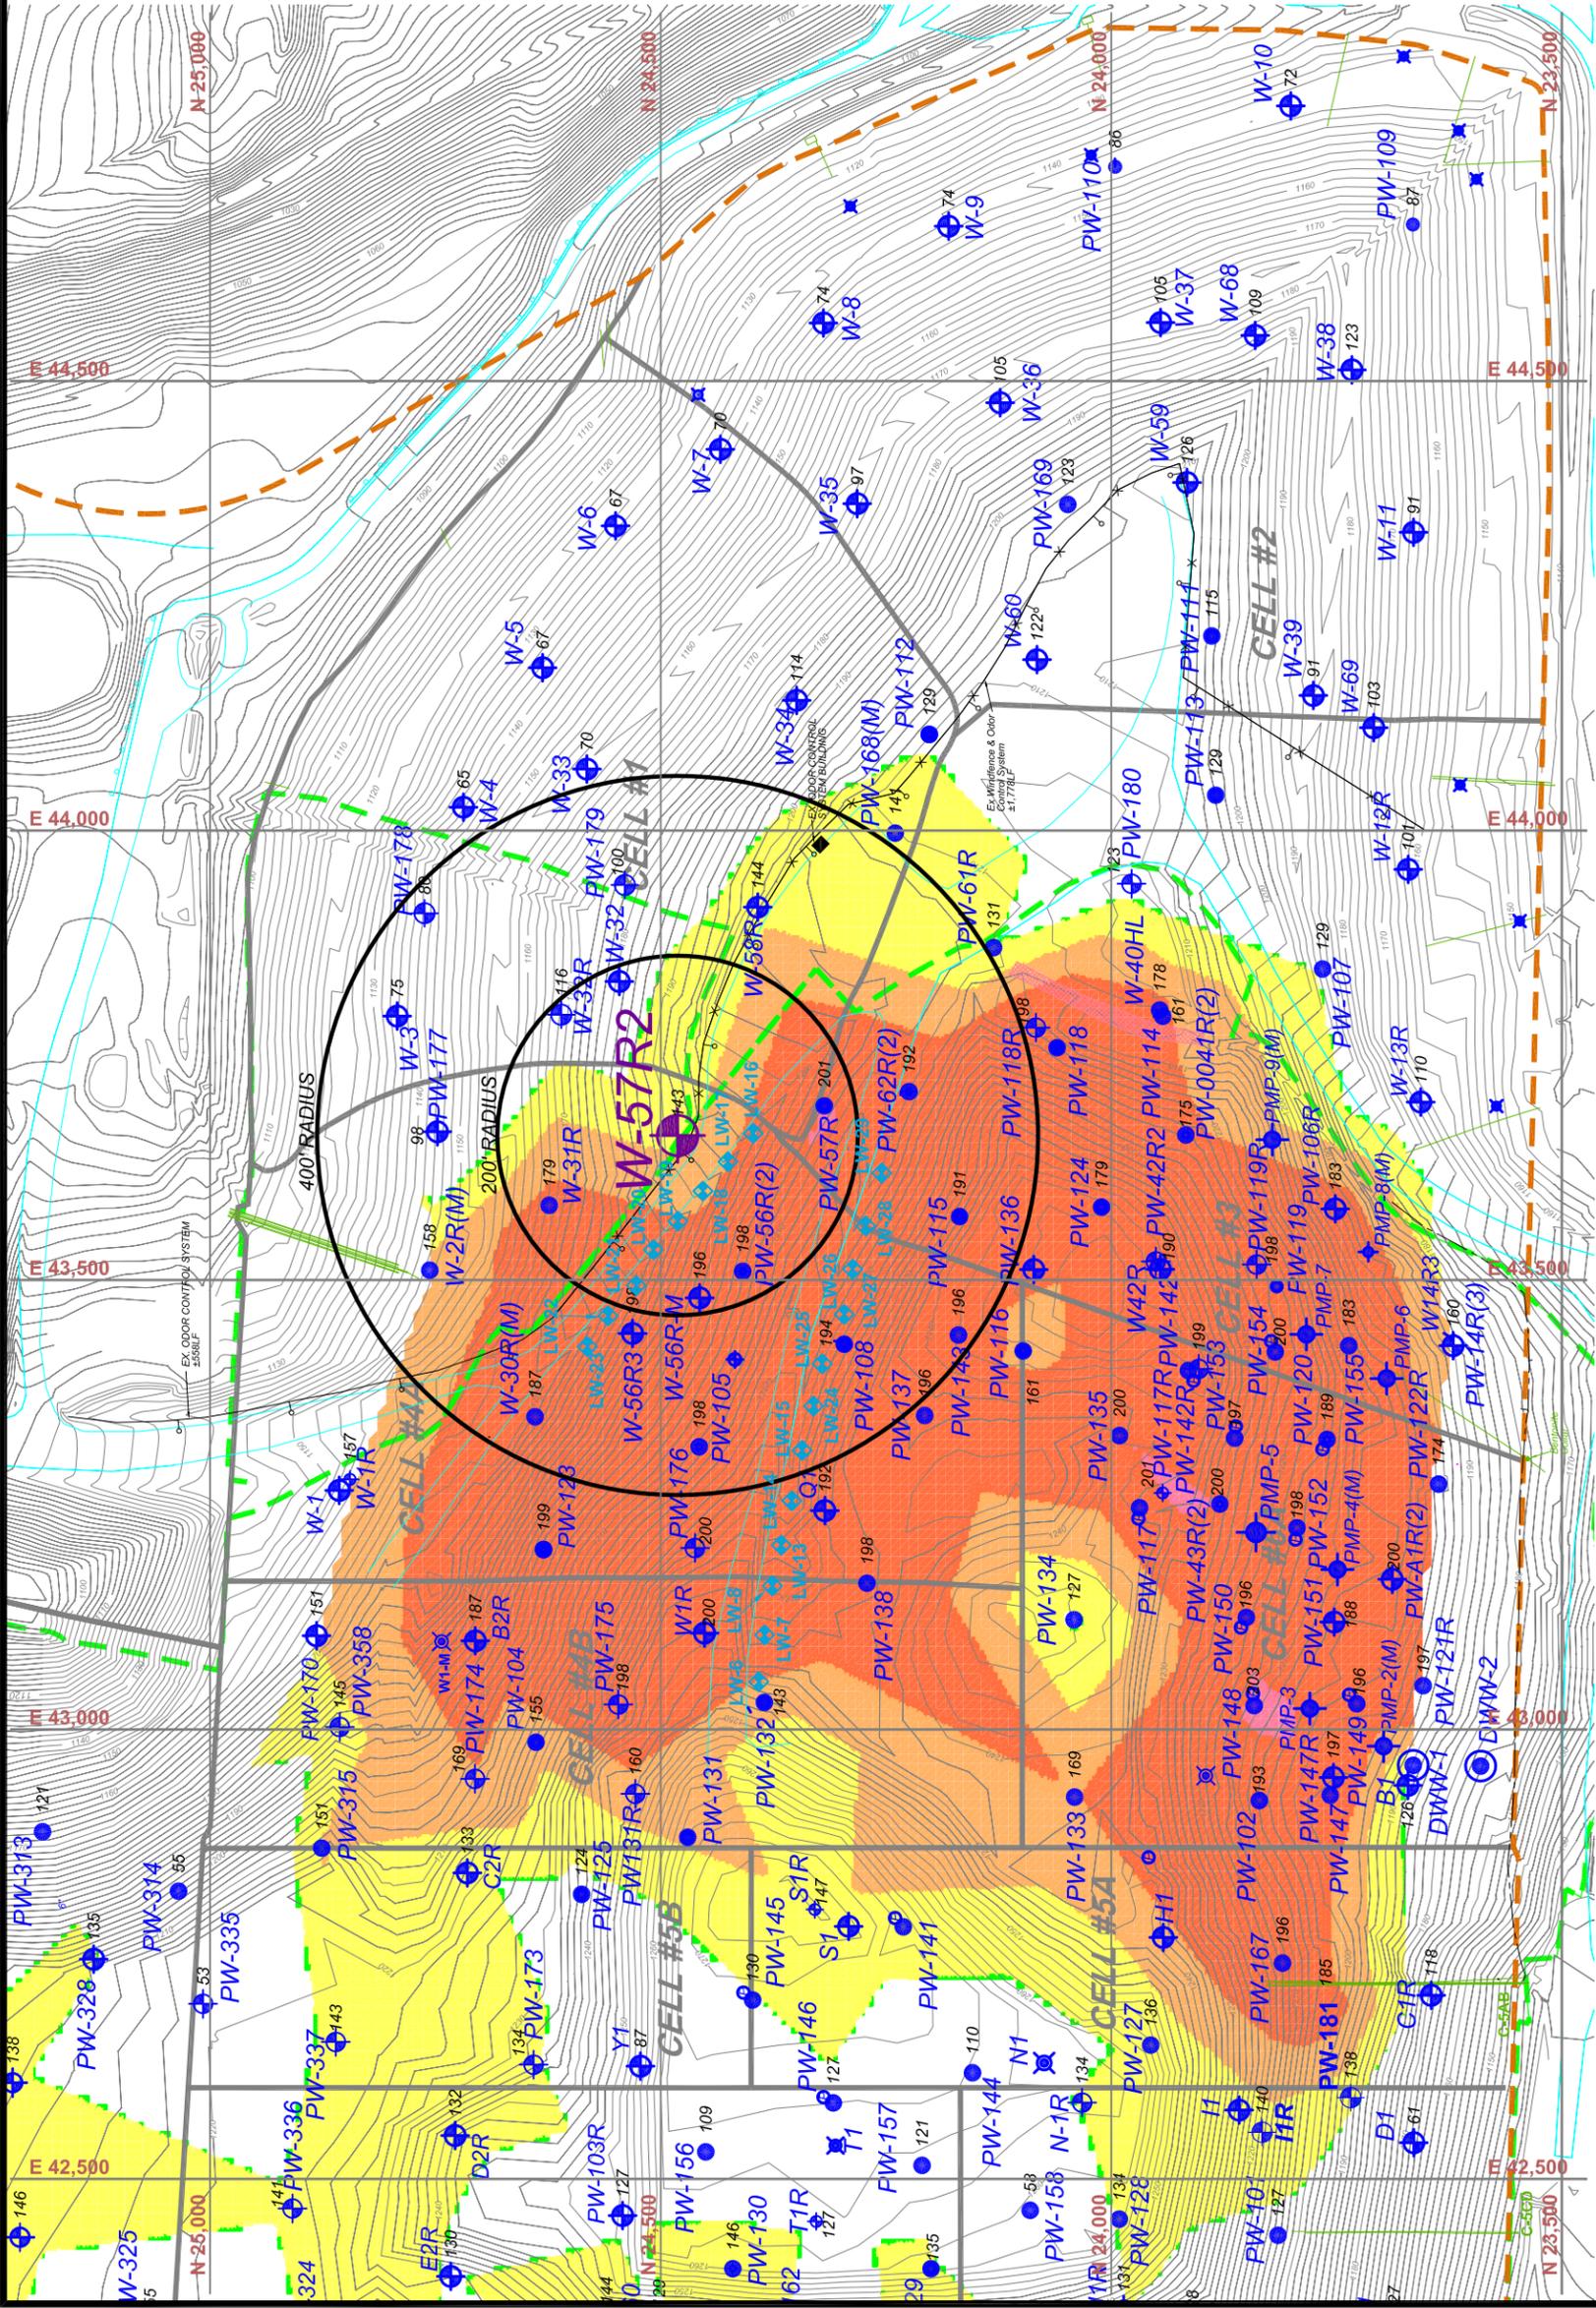
Figure 1 – Plan Location, W-57R2 Incident, October 2008

The location of W-57R2 is shown on the attached Figure 1 along with the site-wide wellhead temperatures measured in October 2008. This area is at the eastern extent of the area impacted by the ongoing reaction at the facility. Note also that it is at the edge of an area that has been capped with a temporary FML cap (indicated by the heavy dashed green line on Figure 1). Well logs for W-57R2 are presented in Attachment A.

3. Extraction rates for 44 landfill gas extraction points (see Figure 1 and Table 1, column labeled "Turned Down as of Nov. 3, 2008") within about 400' of W-57R2 were substantially reduced to limit the potential for oxygen intrusion. Daily monitoring of these 44 wells was initiated.

1. Starting on November 10, monitoring, adjustment, evaluation, and historic trending have been modified to incorporate only 15 extraction locations within approximately 200' of W-57R2 (see Figure 1 for locations and Table 1, column labeled "Turned Down as of Nov. 10, 2008"). The monitoring of these 15 locations will be conducted on a 3 times per work week basis (Monday, Wednesday, and Friday). Tuning will be conducted to minimize the potential for oxygen intrusion into the area immediately surrounding W-57R2. See Attachment C for current GEM data graphs for these wells.

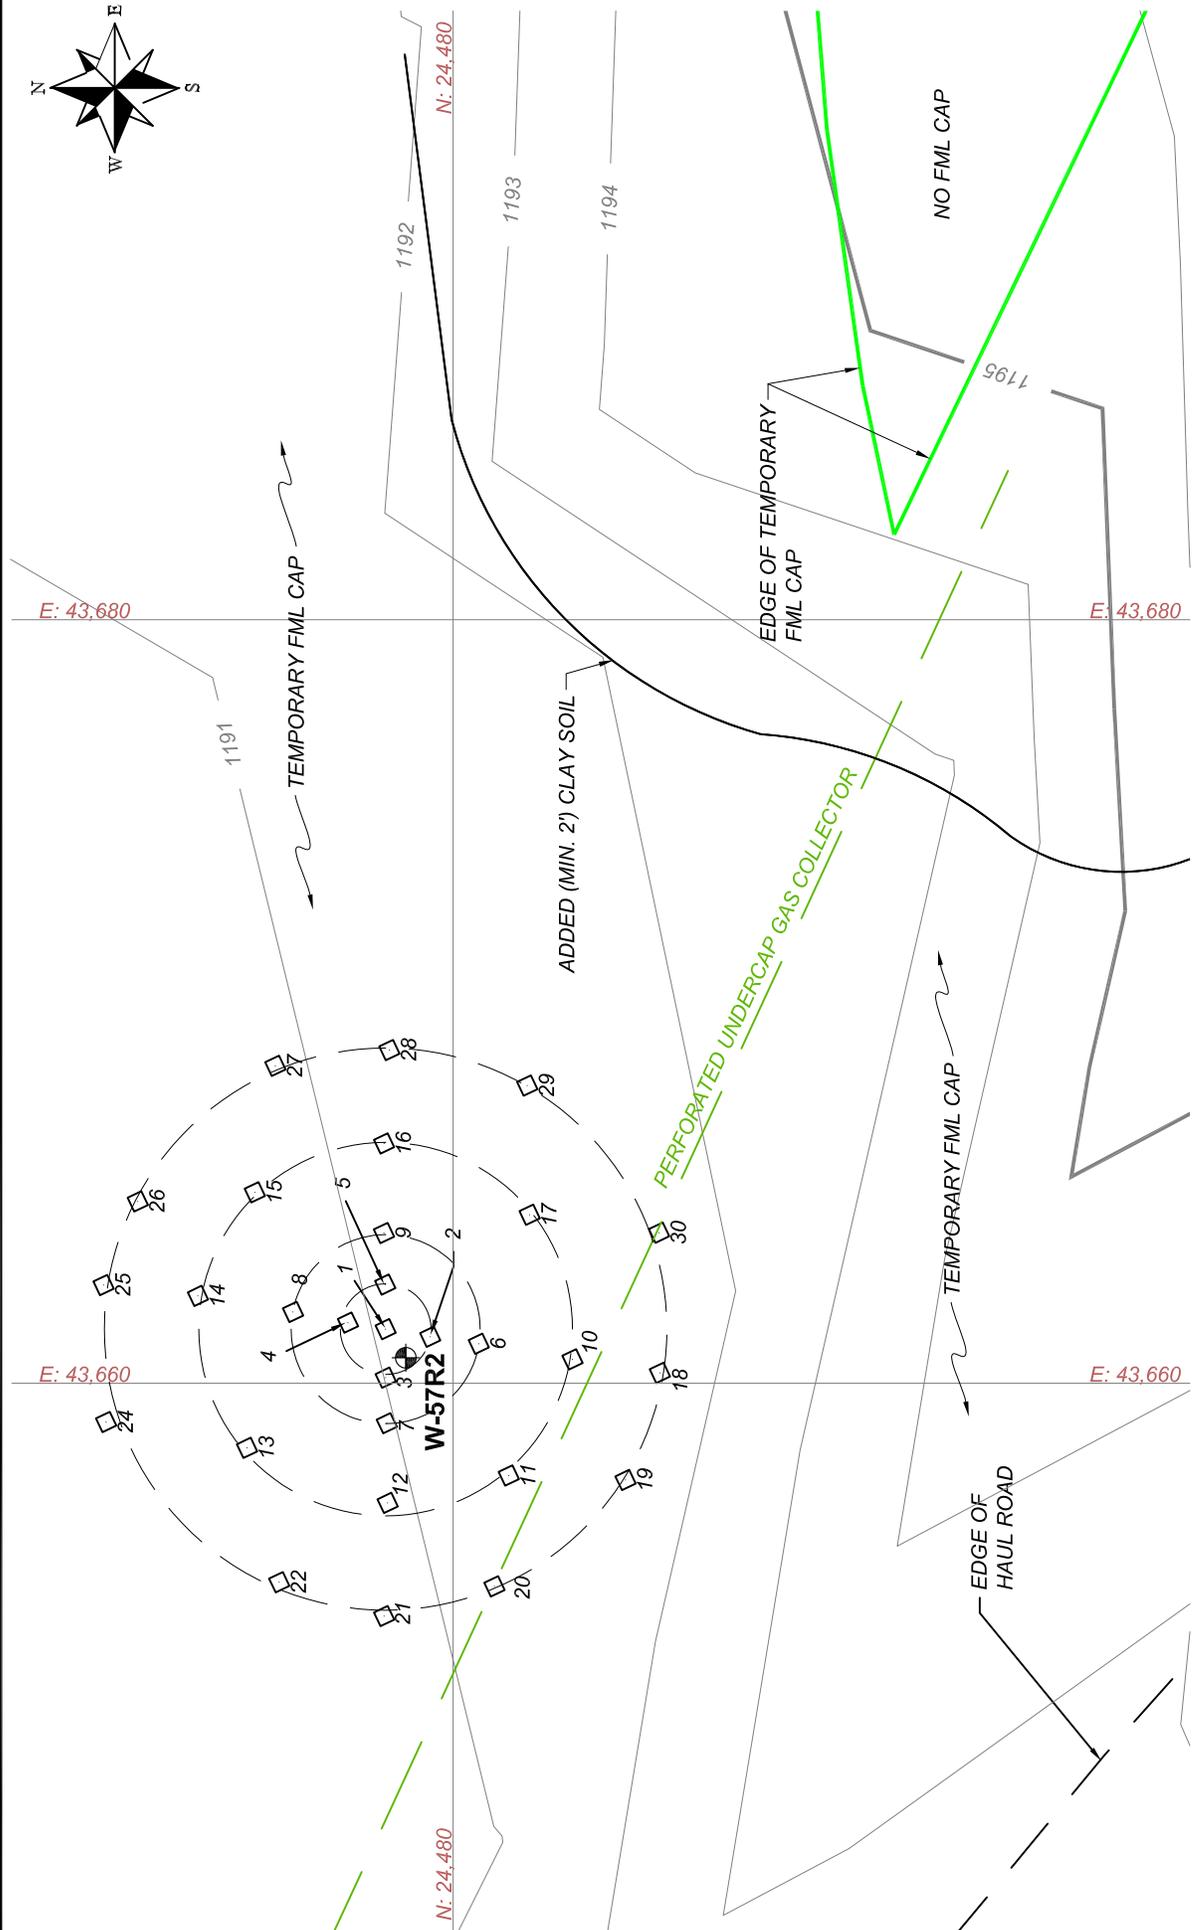
Figure 2 – Monitoring Adjacent to W-57R2

1. On Monday, November 3, 2008, Darrin Hartman of AEGL was assigned to coordinate additional efforts and response to the event at W-57R2.
2. A series of surface temperature and settlement monitoring points was established immediately around the well (see Figure 2). Liner surface temperature surveys and ground elevation surveys were initiated at the monitoring points.

4. Additional compacted soil was placed over the adjacent liner toe trench and liner tie-in location in order to better seal the surface area and reduce the potential for oxygen intrusion into this area (see Figure 2 for approximate limits of added soil).

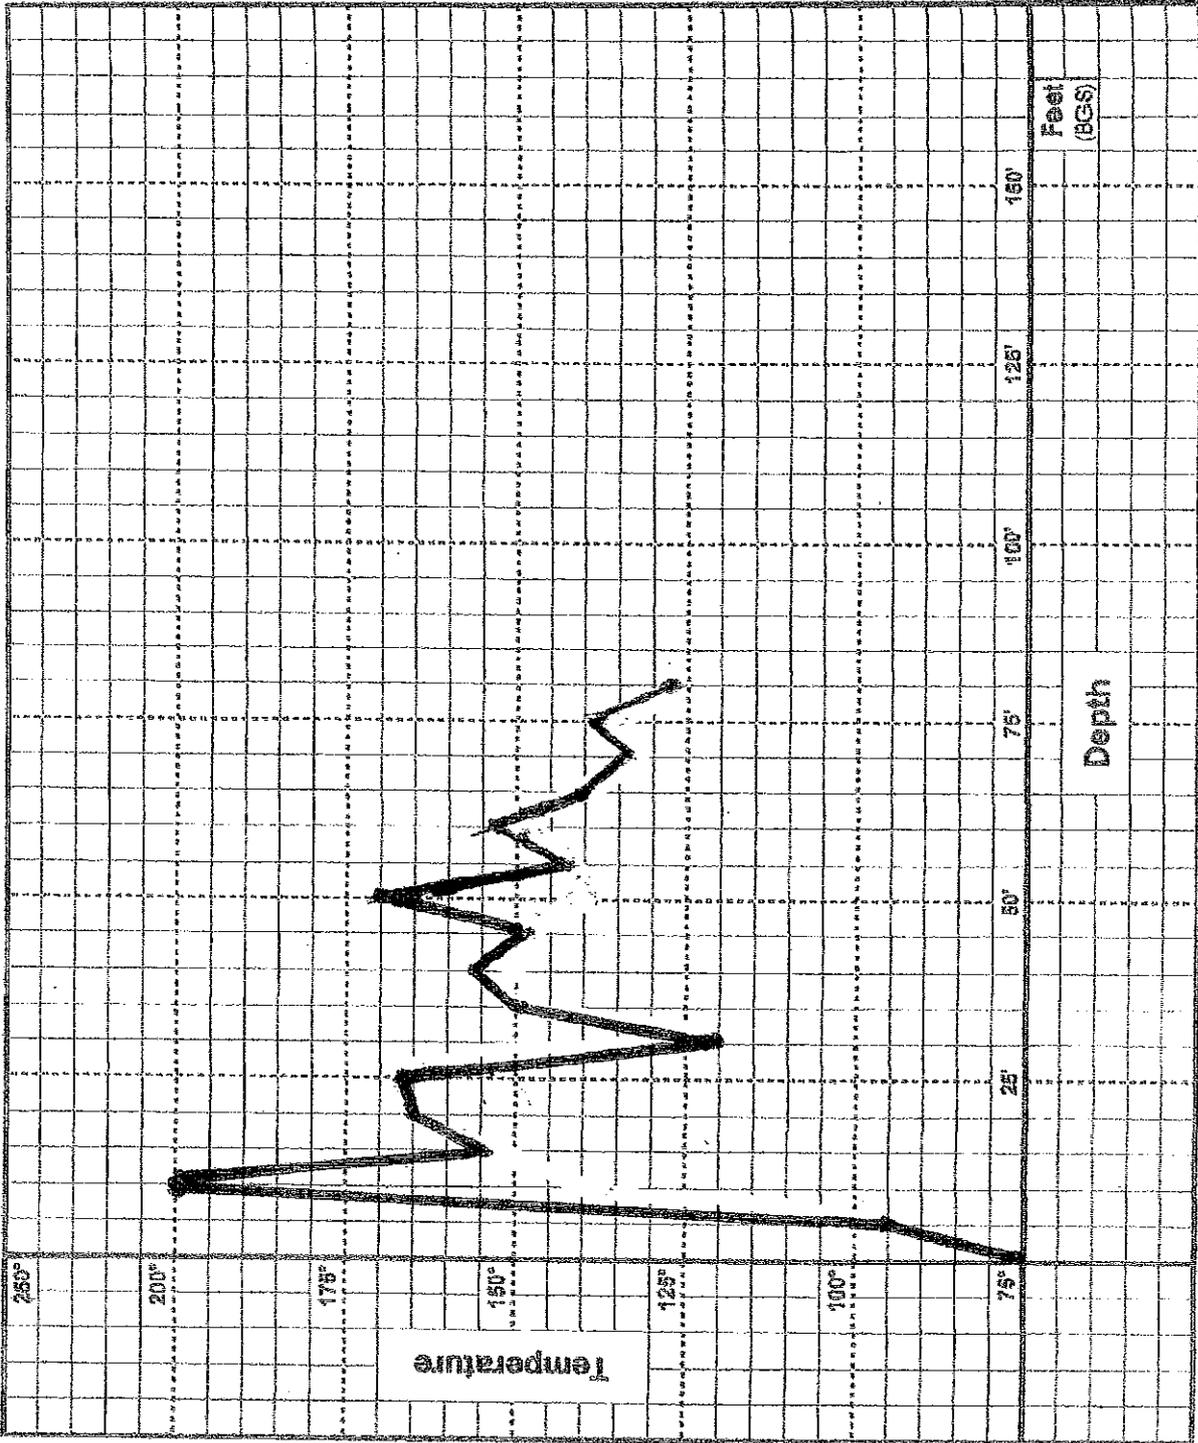
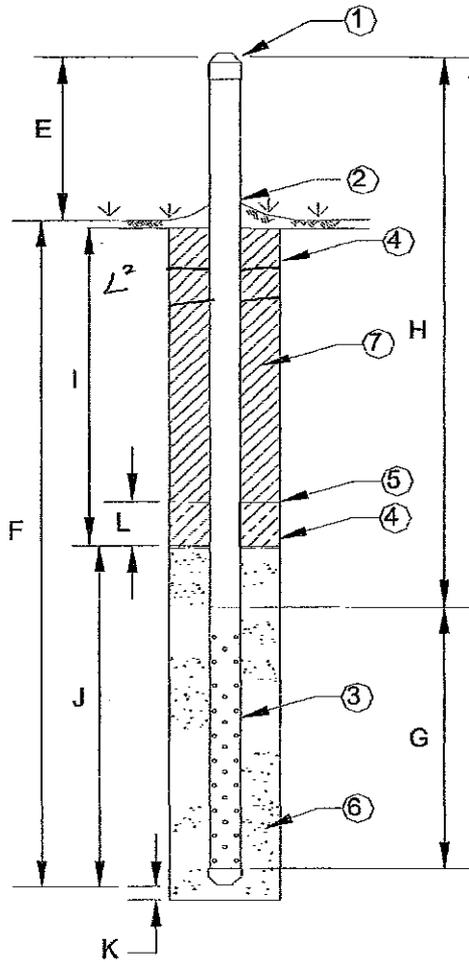
Attachment A - Well Logs for W-57R2

The well logs for W-57R2 (Attachment A) indicate three pockets of aluminum dross: one at 12 feet deep (2 to 3 feet thick), another at 32 feet deep (about one to two feet thick), and another at 47 feet deep (thickness not noted). The cuttings from the vicinity of the 12-foot deep dross pocket measured 200 deg. F during drilling.

Aluminum Dross encountered @ 12'. Dross Layer approximately 2-3'.  
 Aluminum Dross encountered @ 32'. Dross layer approximately 1-2' deep.  
 Check Temp's. Encountered add'l Dross @ 45'. Dross mat'l sampled  
 AT ALL ELEVATIONS of discovery.  
 P - Paper, PL - Plastic, W - wood, M - metal, WR - Wire, AF - Auto Shut,  
 HHT - Household Trash, AD - Aluminum Dross

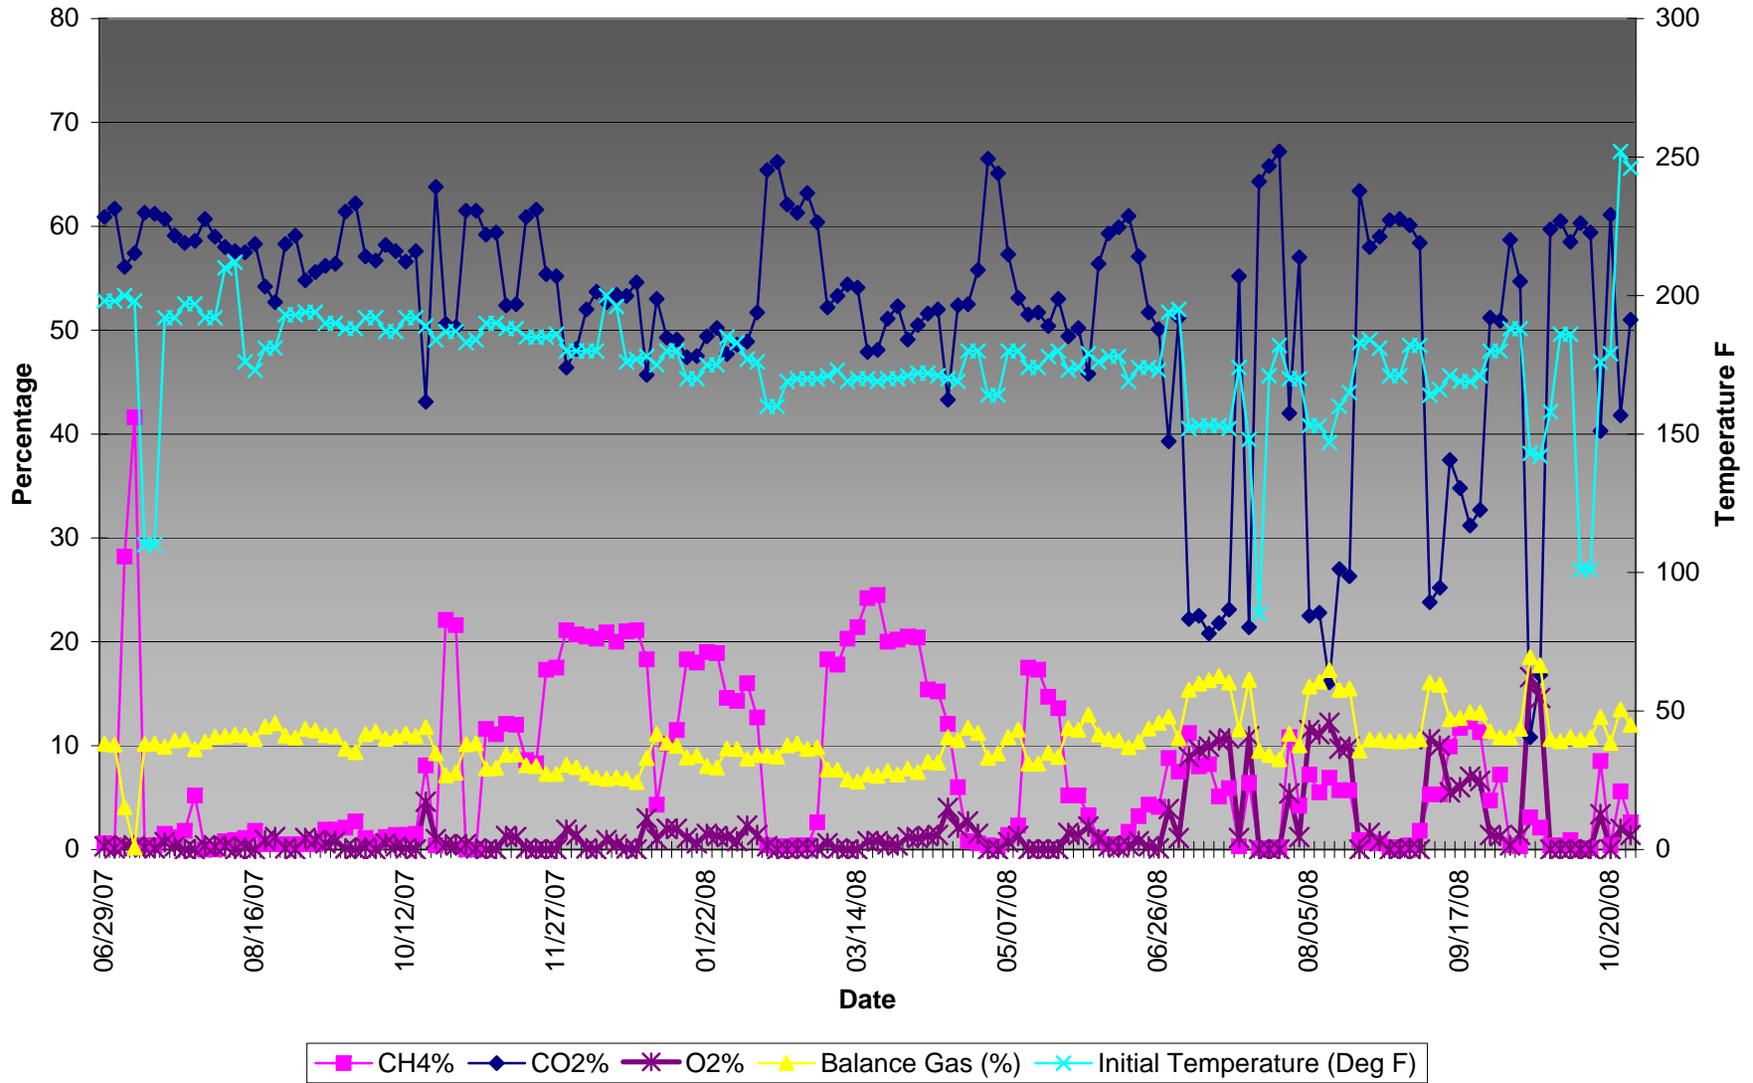
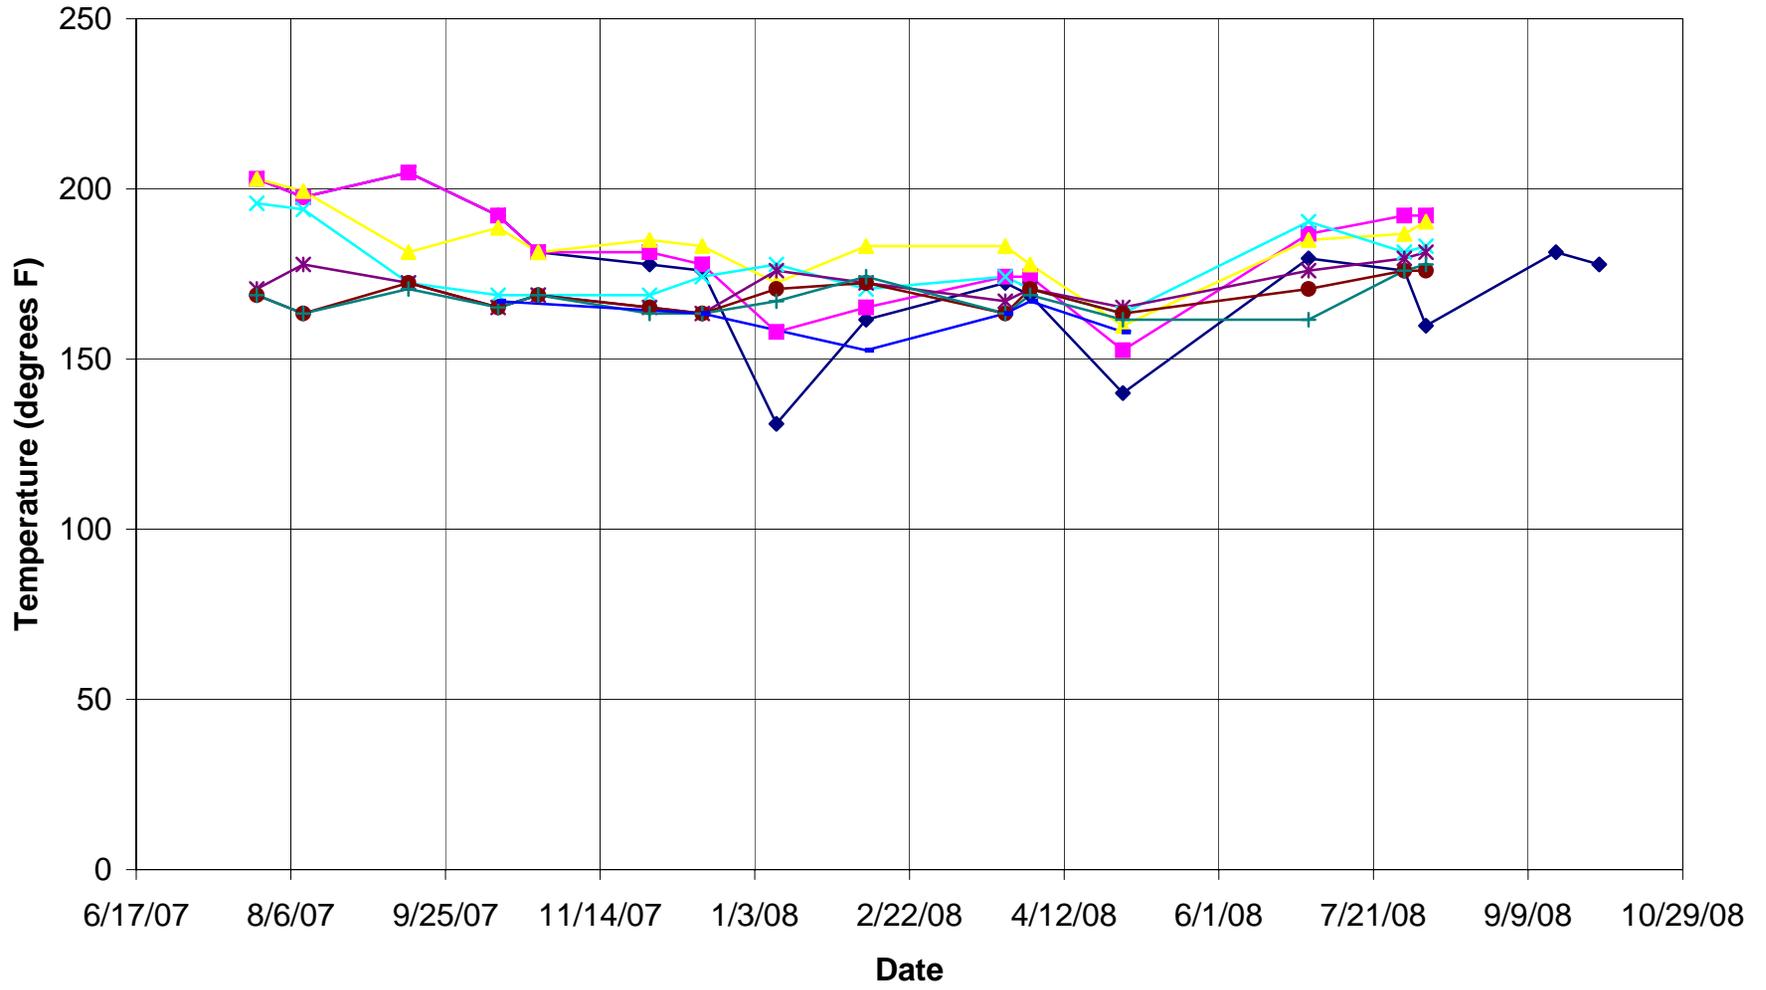
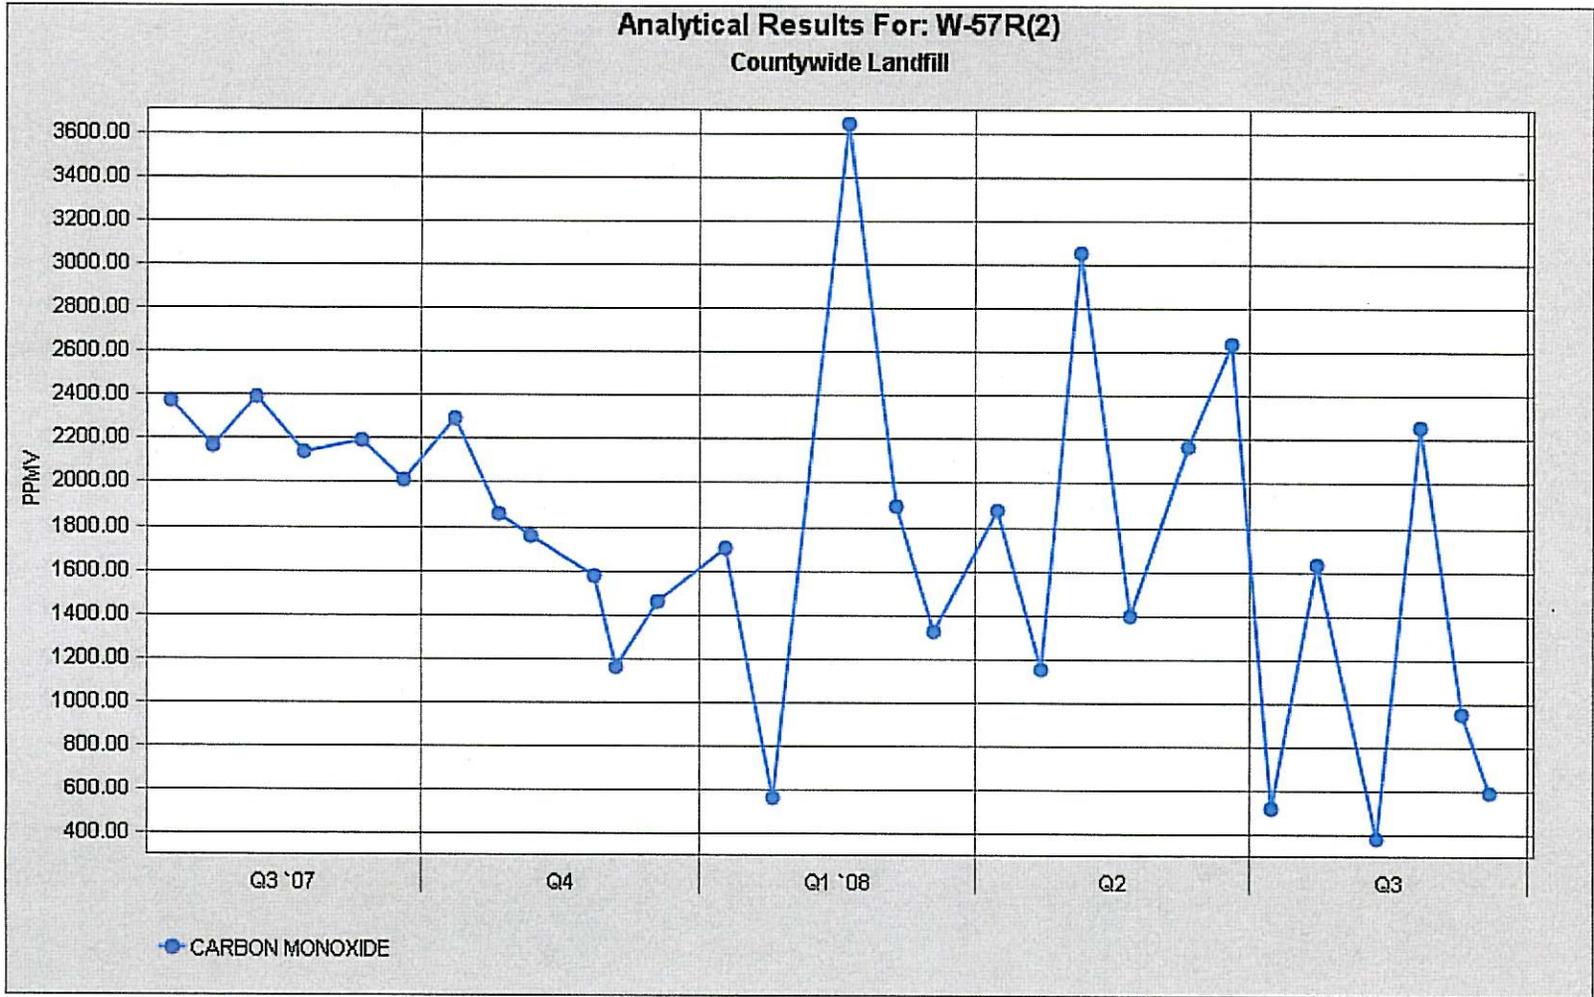
Attachment B – Data Plots for W-57R2

W-57R2 time plots for wellhead temperature, downhole temperature, and carbon monoxide are provided in Attachment B. The well is impacted by the reaction and, as such, exhibits low methane, elevated temperatures, and high carbon monoxide levels. Data values vary widely—possibly due to location at the edge of a reaction-impacted boundary where the well may be susceptible to transient levels. Data from the week before the incident is not noticeably outside the "normal" operational levels for this well. However, the wellhead temperature indicated a significant rise in the October 31 reading, just two days before the incident.

In July 2008, a pump failed in W-57R2 and blocked further access beyond about 12 feet deep (same depth as the warm pocket of dross); since that time, downhole access beyond 12 feet deep has not been possible and that is reflected on the downhole temperature plot provided in Attachment B.

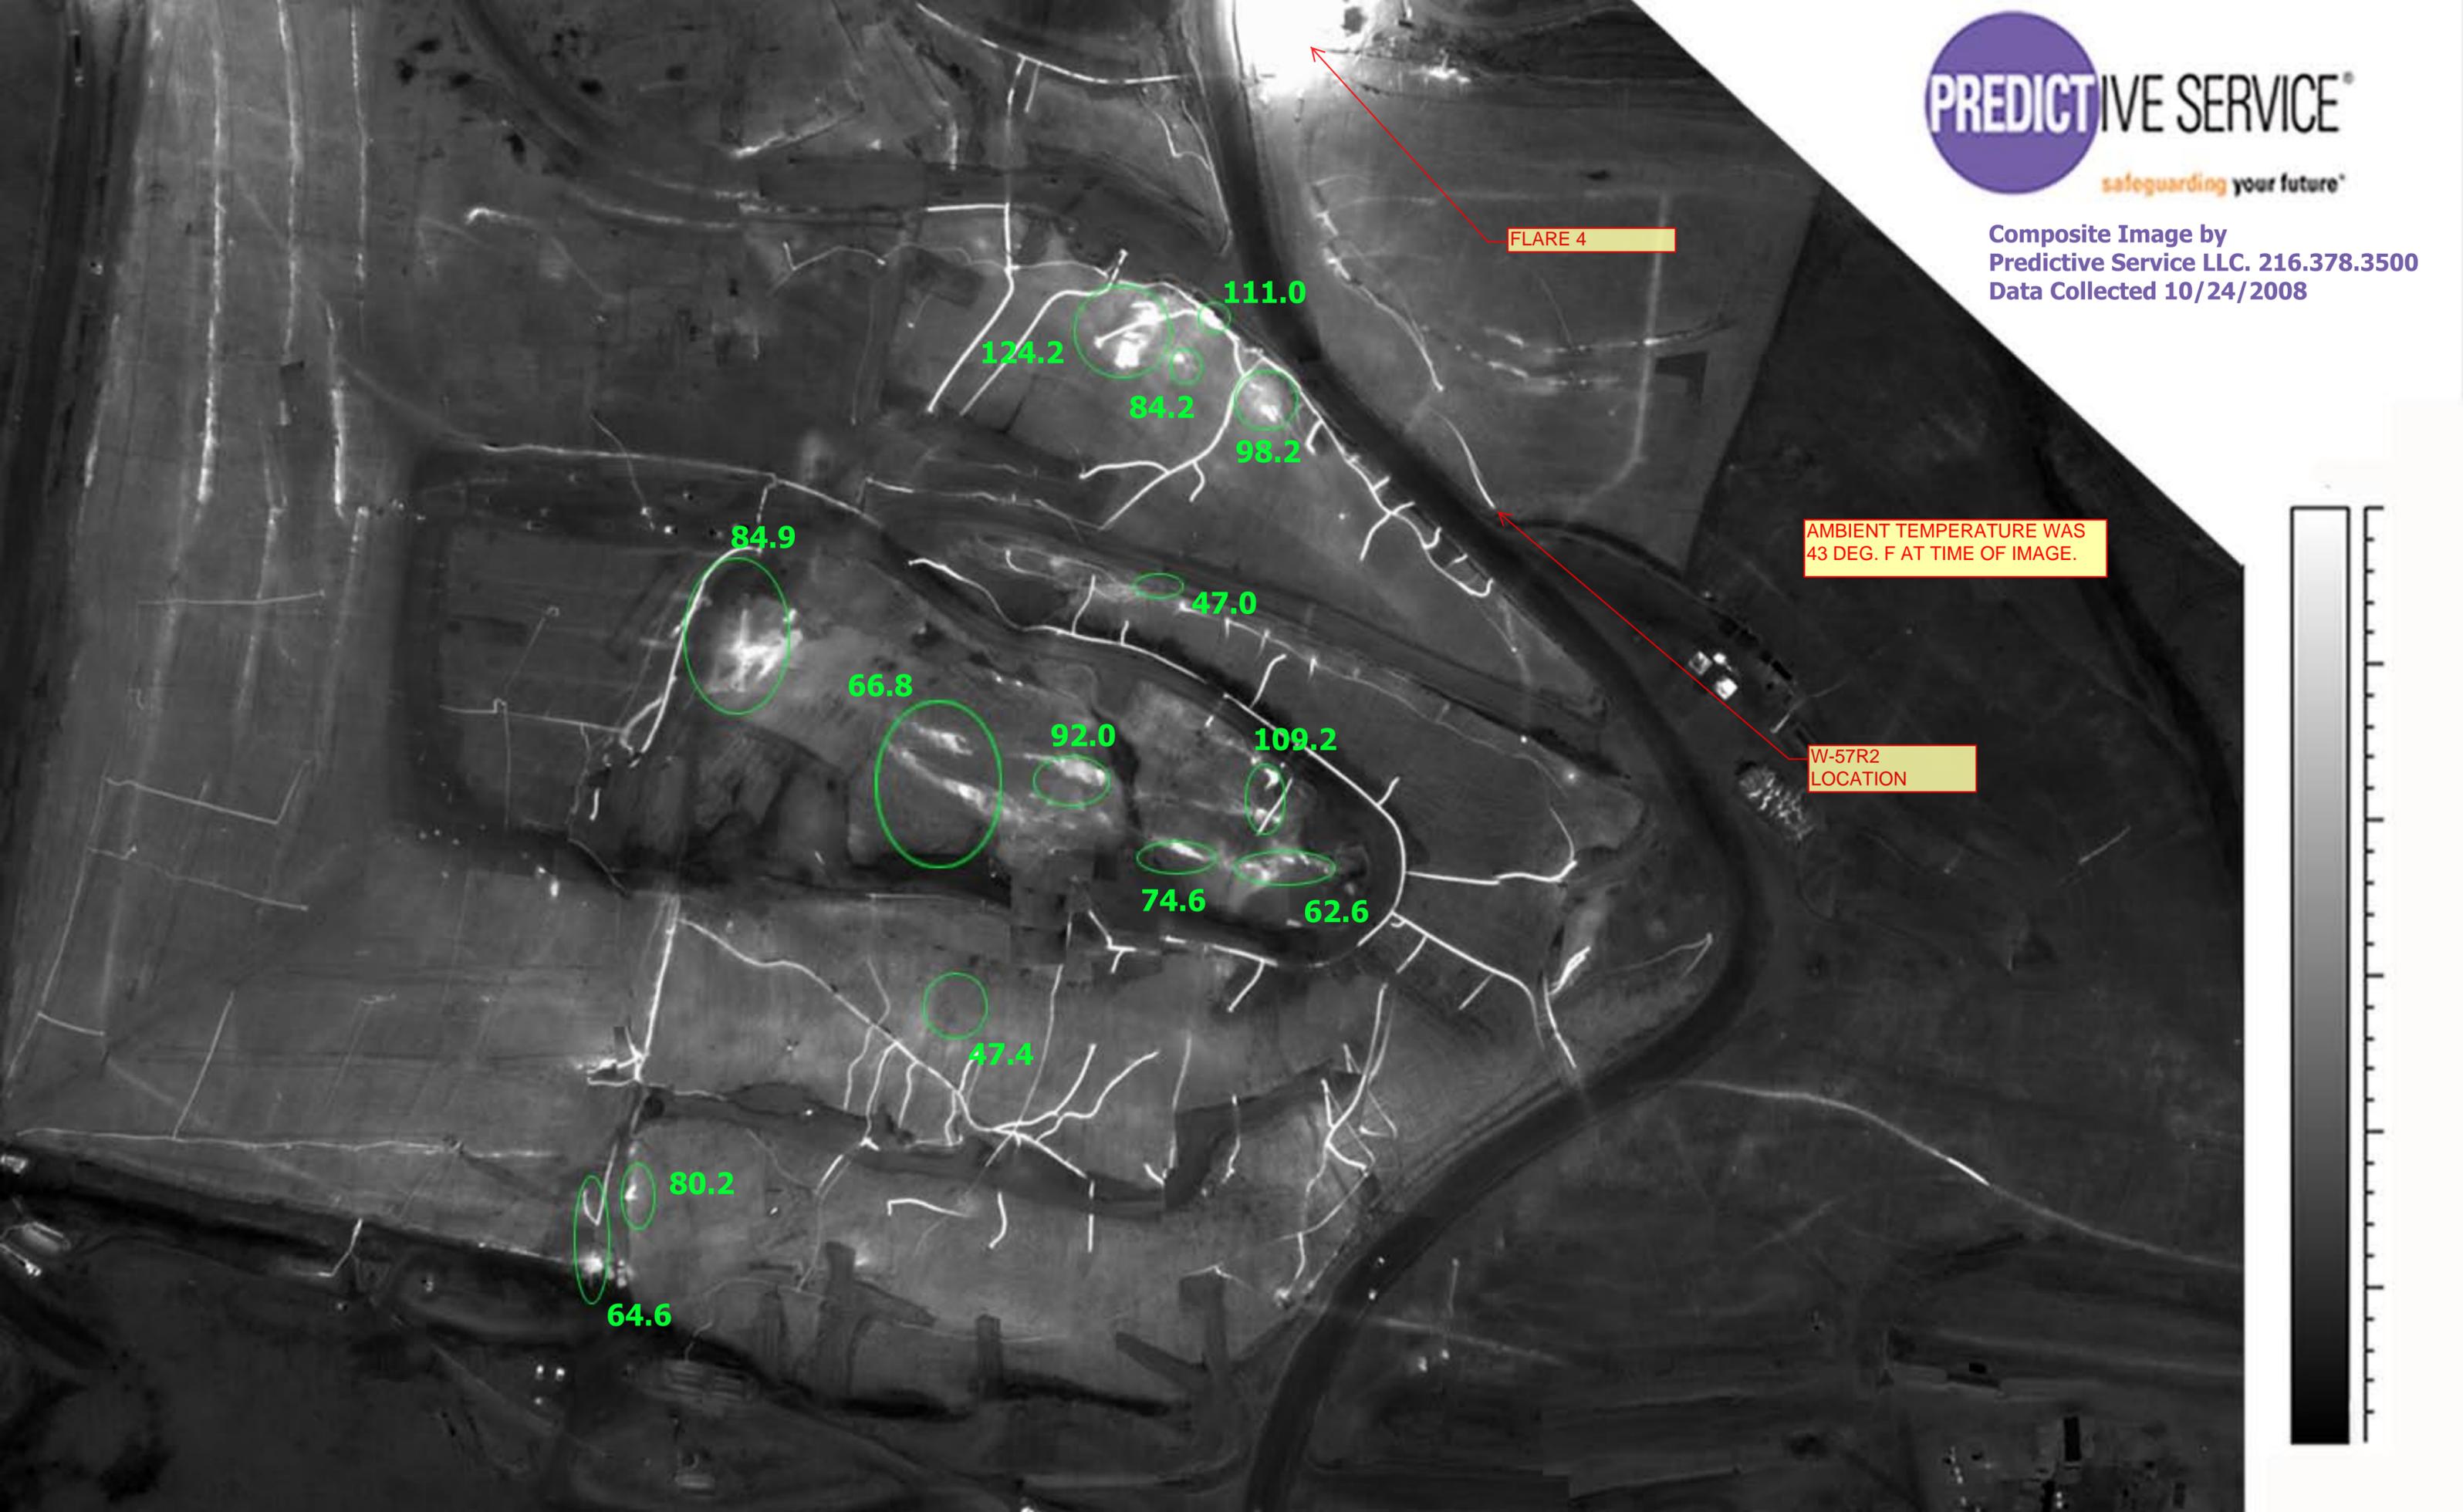
Attachment D – Infrared Photo, October 24, 2008

Examination of the October 2008 site infrared photograph (see Attachment D) does not show any evidence of subsurface heat at the location of W-57R2.

W-57R2  
LOCATION
