## Countywide Recycling & Disposal Facility

November 26, 2008

RE: Request for Information - W-57R  
Countywide Recycling and Disposal Facility, East Sparta, Ohio

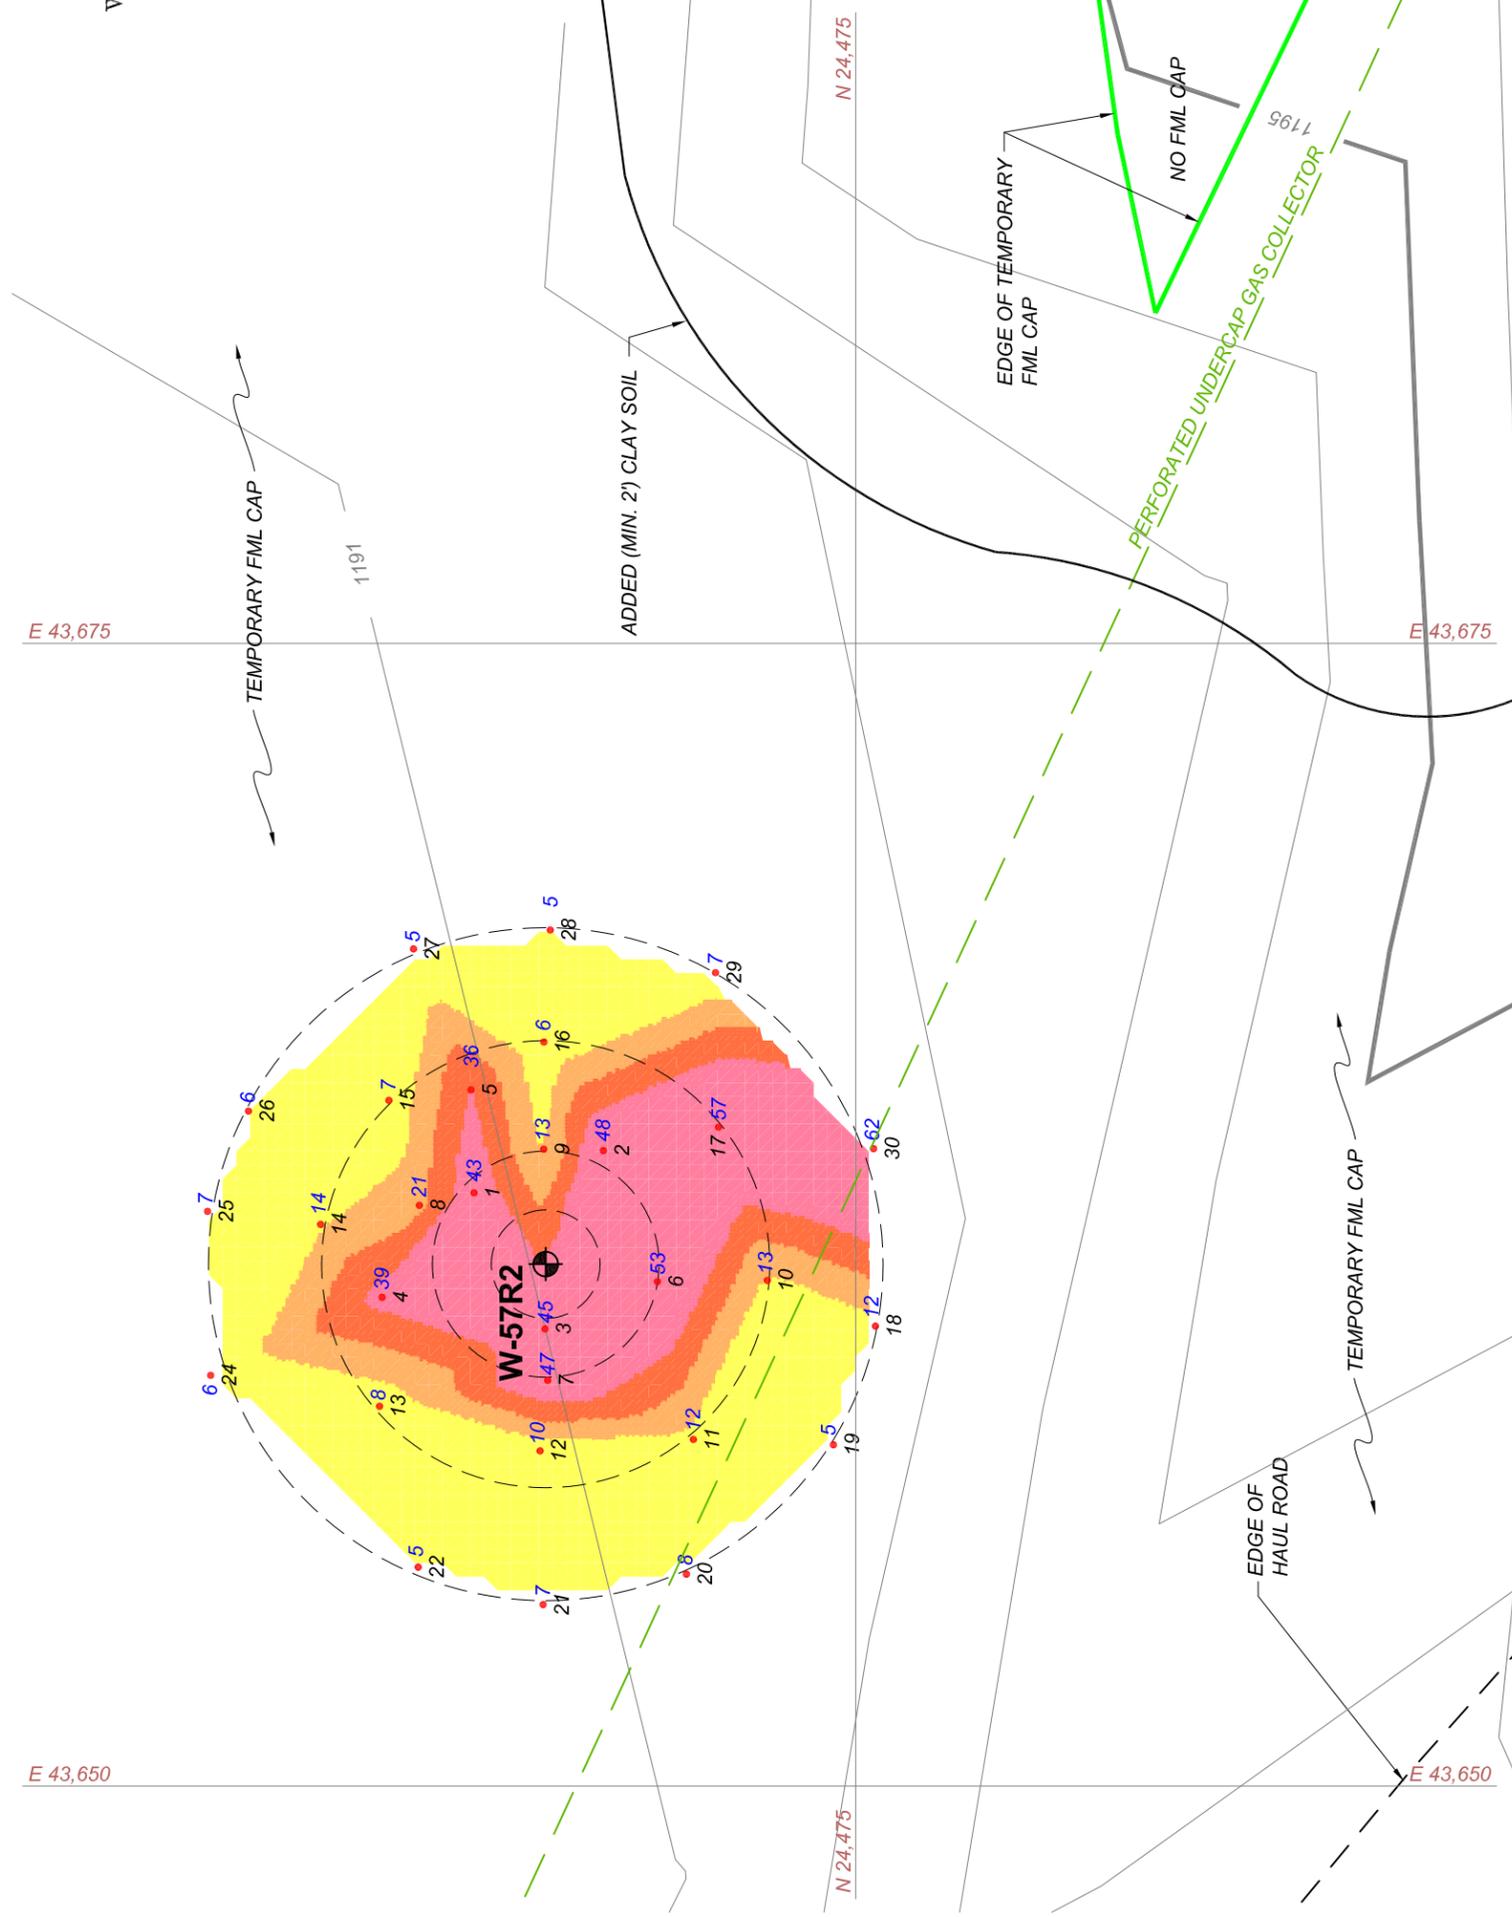
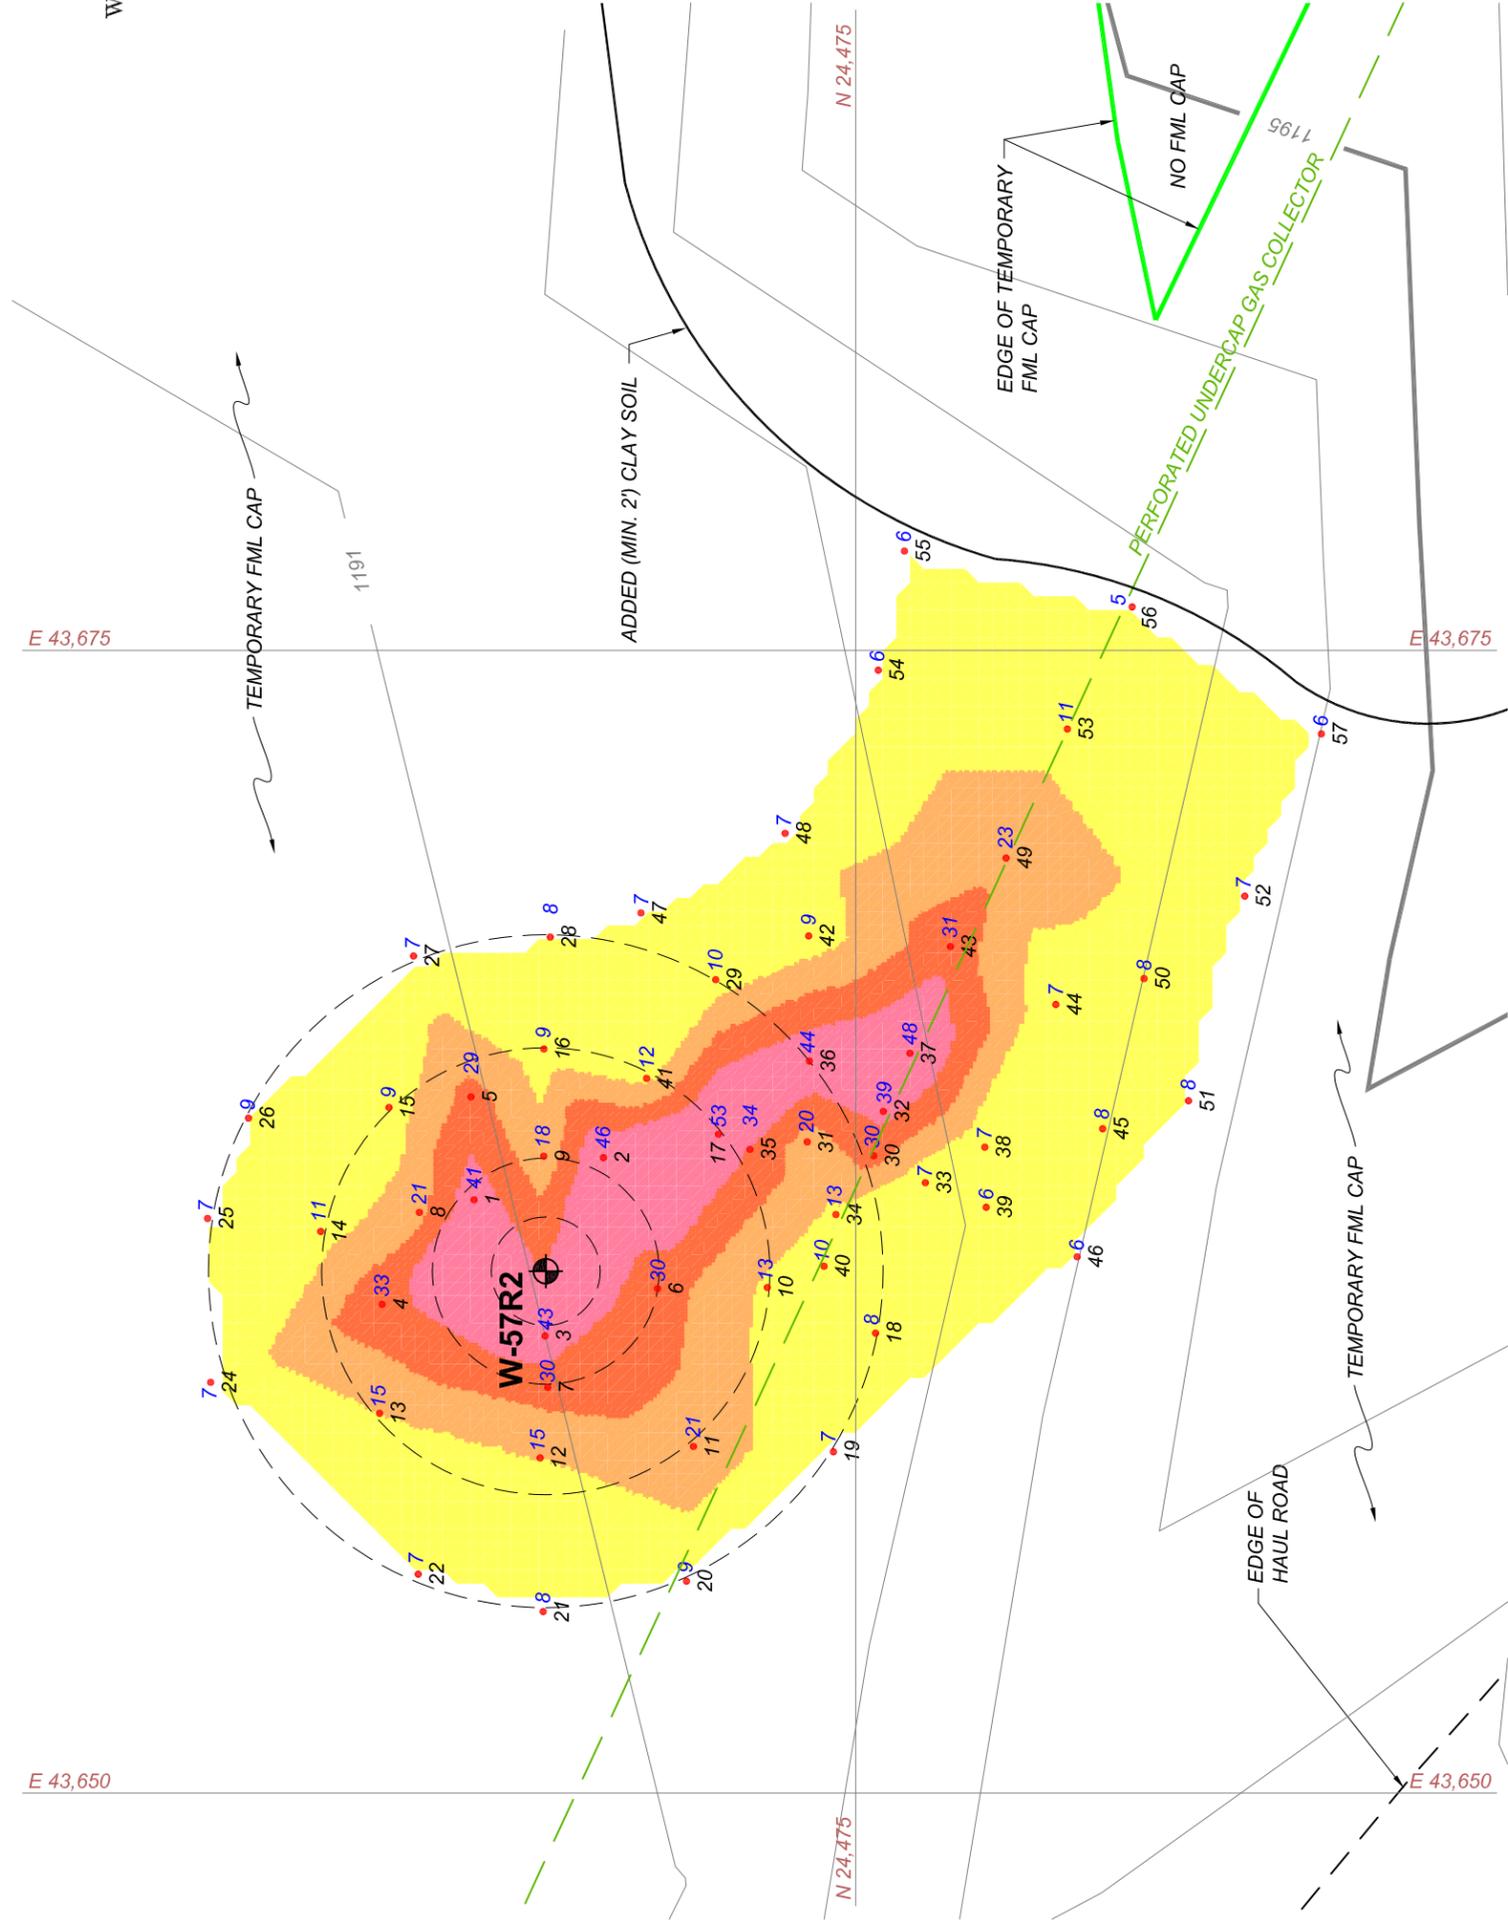
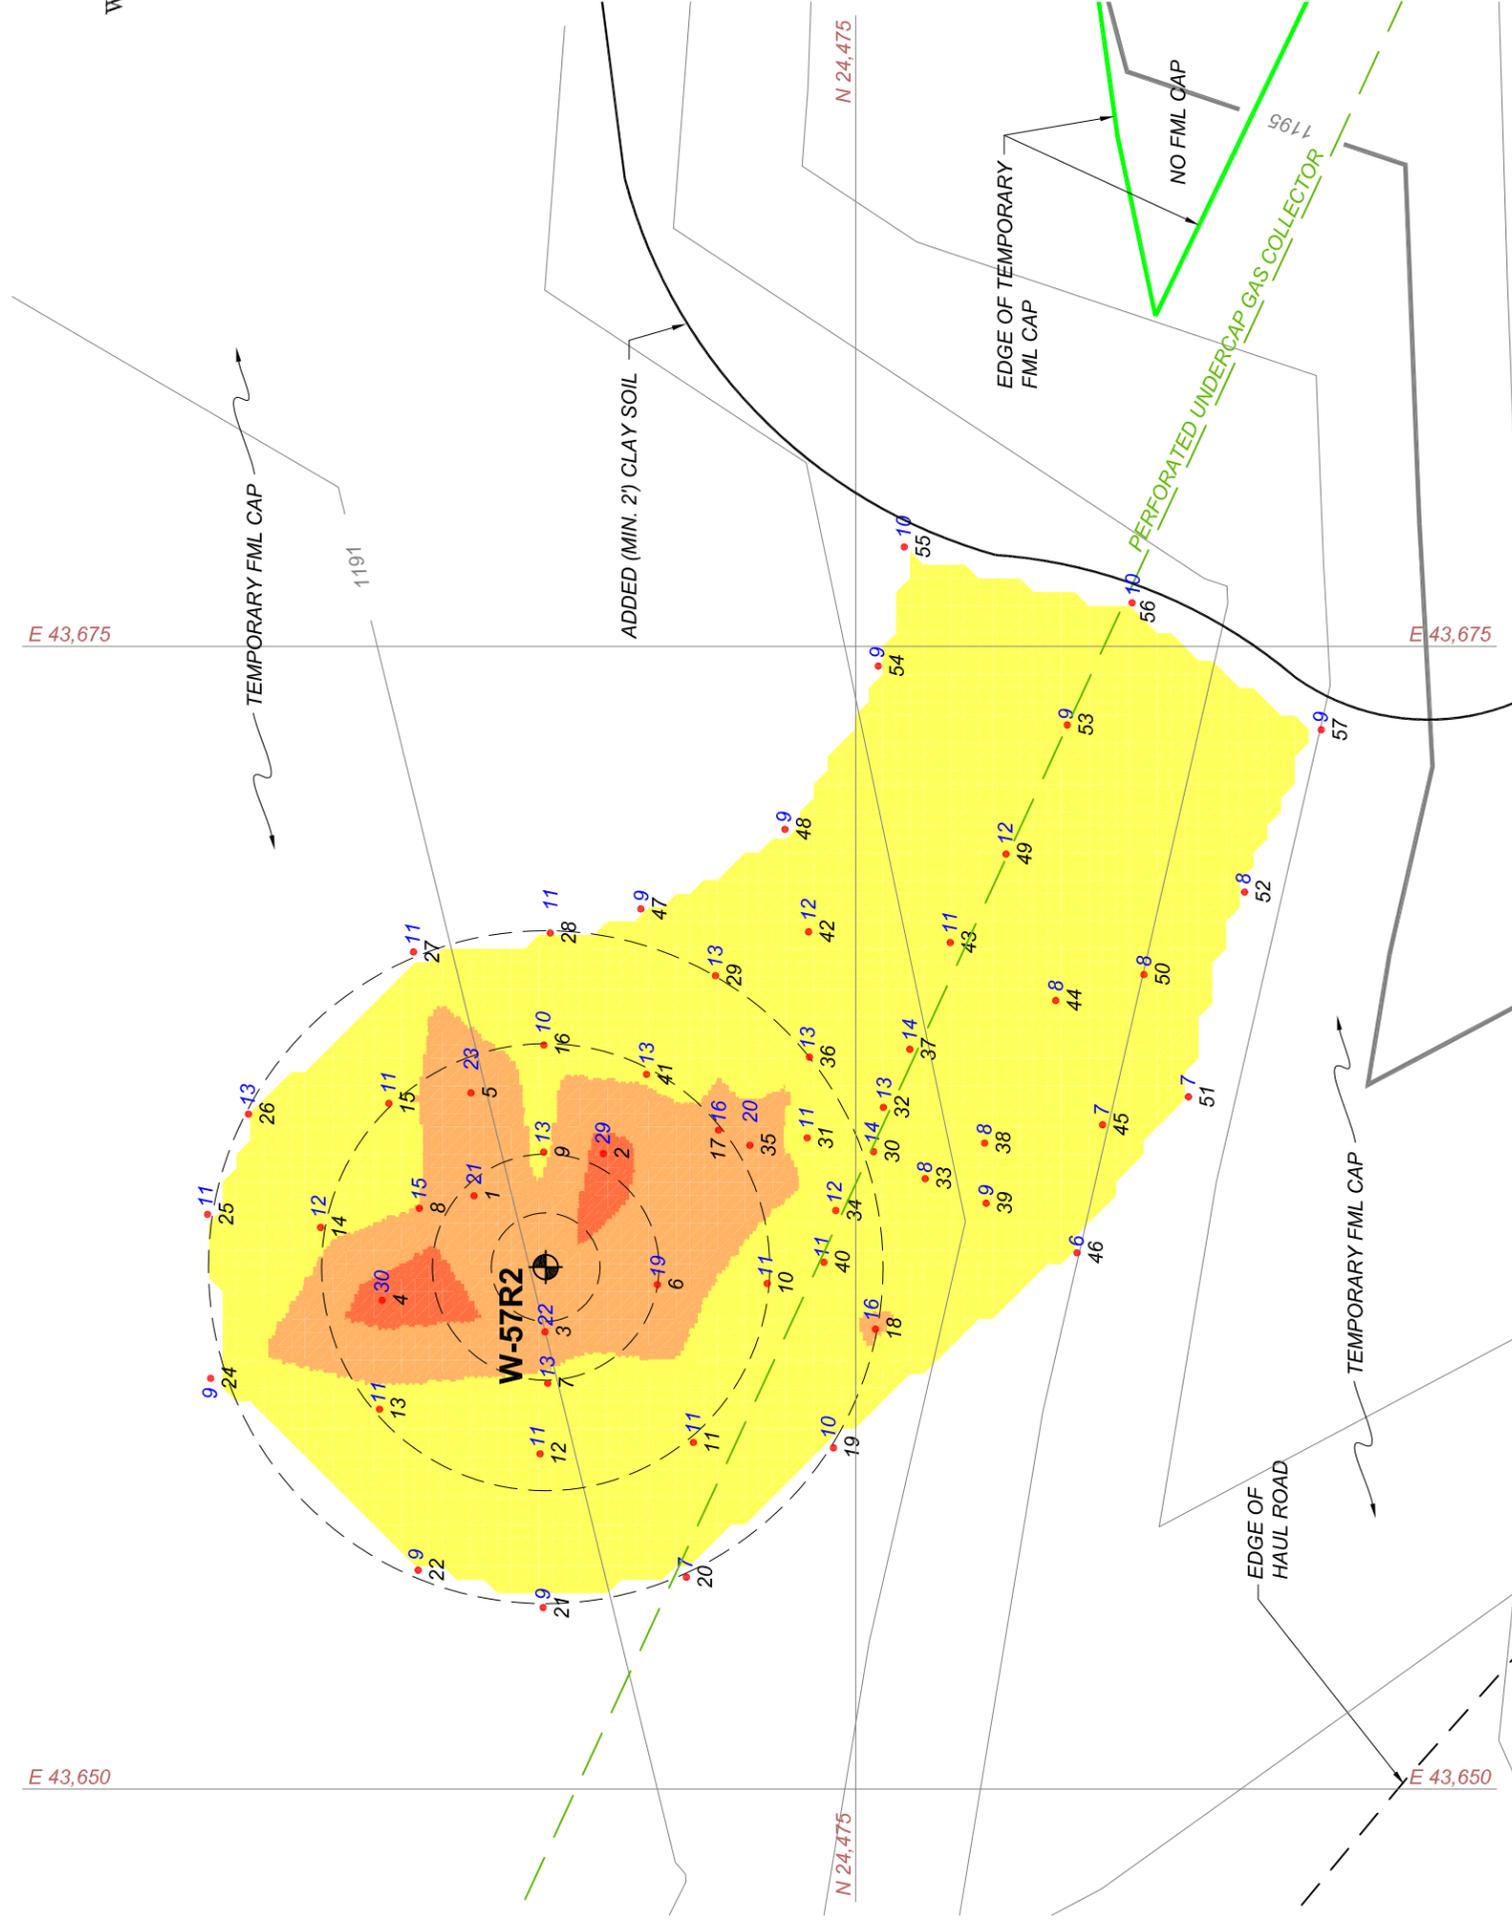
Attachment E – Local Surface Temperature Survey Results

3. A surface temperature survey is being conducted on a once per work day basis (M-F). Plots of weekly temperature results to date are included in Attachment E. These plots show the relative temperature differences between a reference section of HDPE liner material (located under the AEG office trailer) and the surface temperature on HDPE temporary cap in the vicinity of W-57R2. Temperatures are obtained pre-dawn to eliminate heating effects of the sun. This data shows a significant week-to-week cooling around the former well location. Frequency of this survey will be reduced when deemed appropriate.

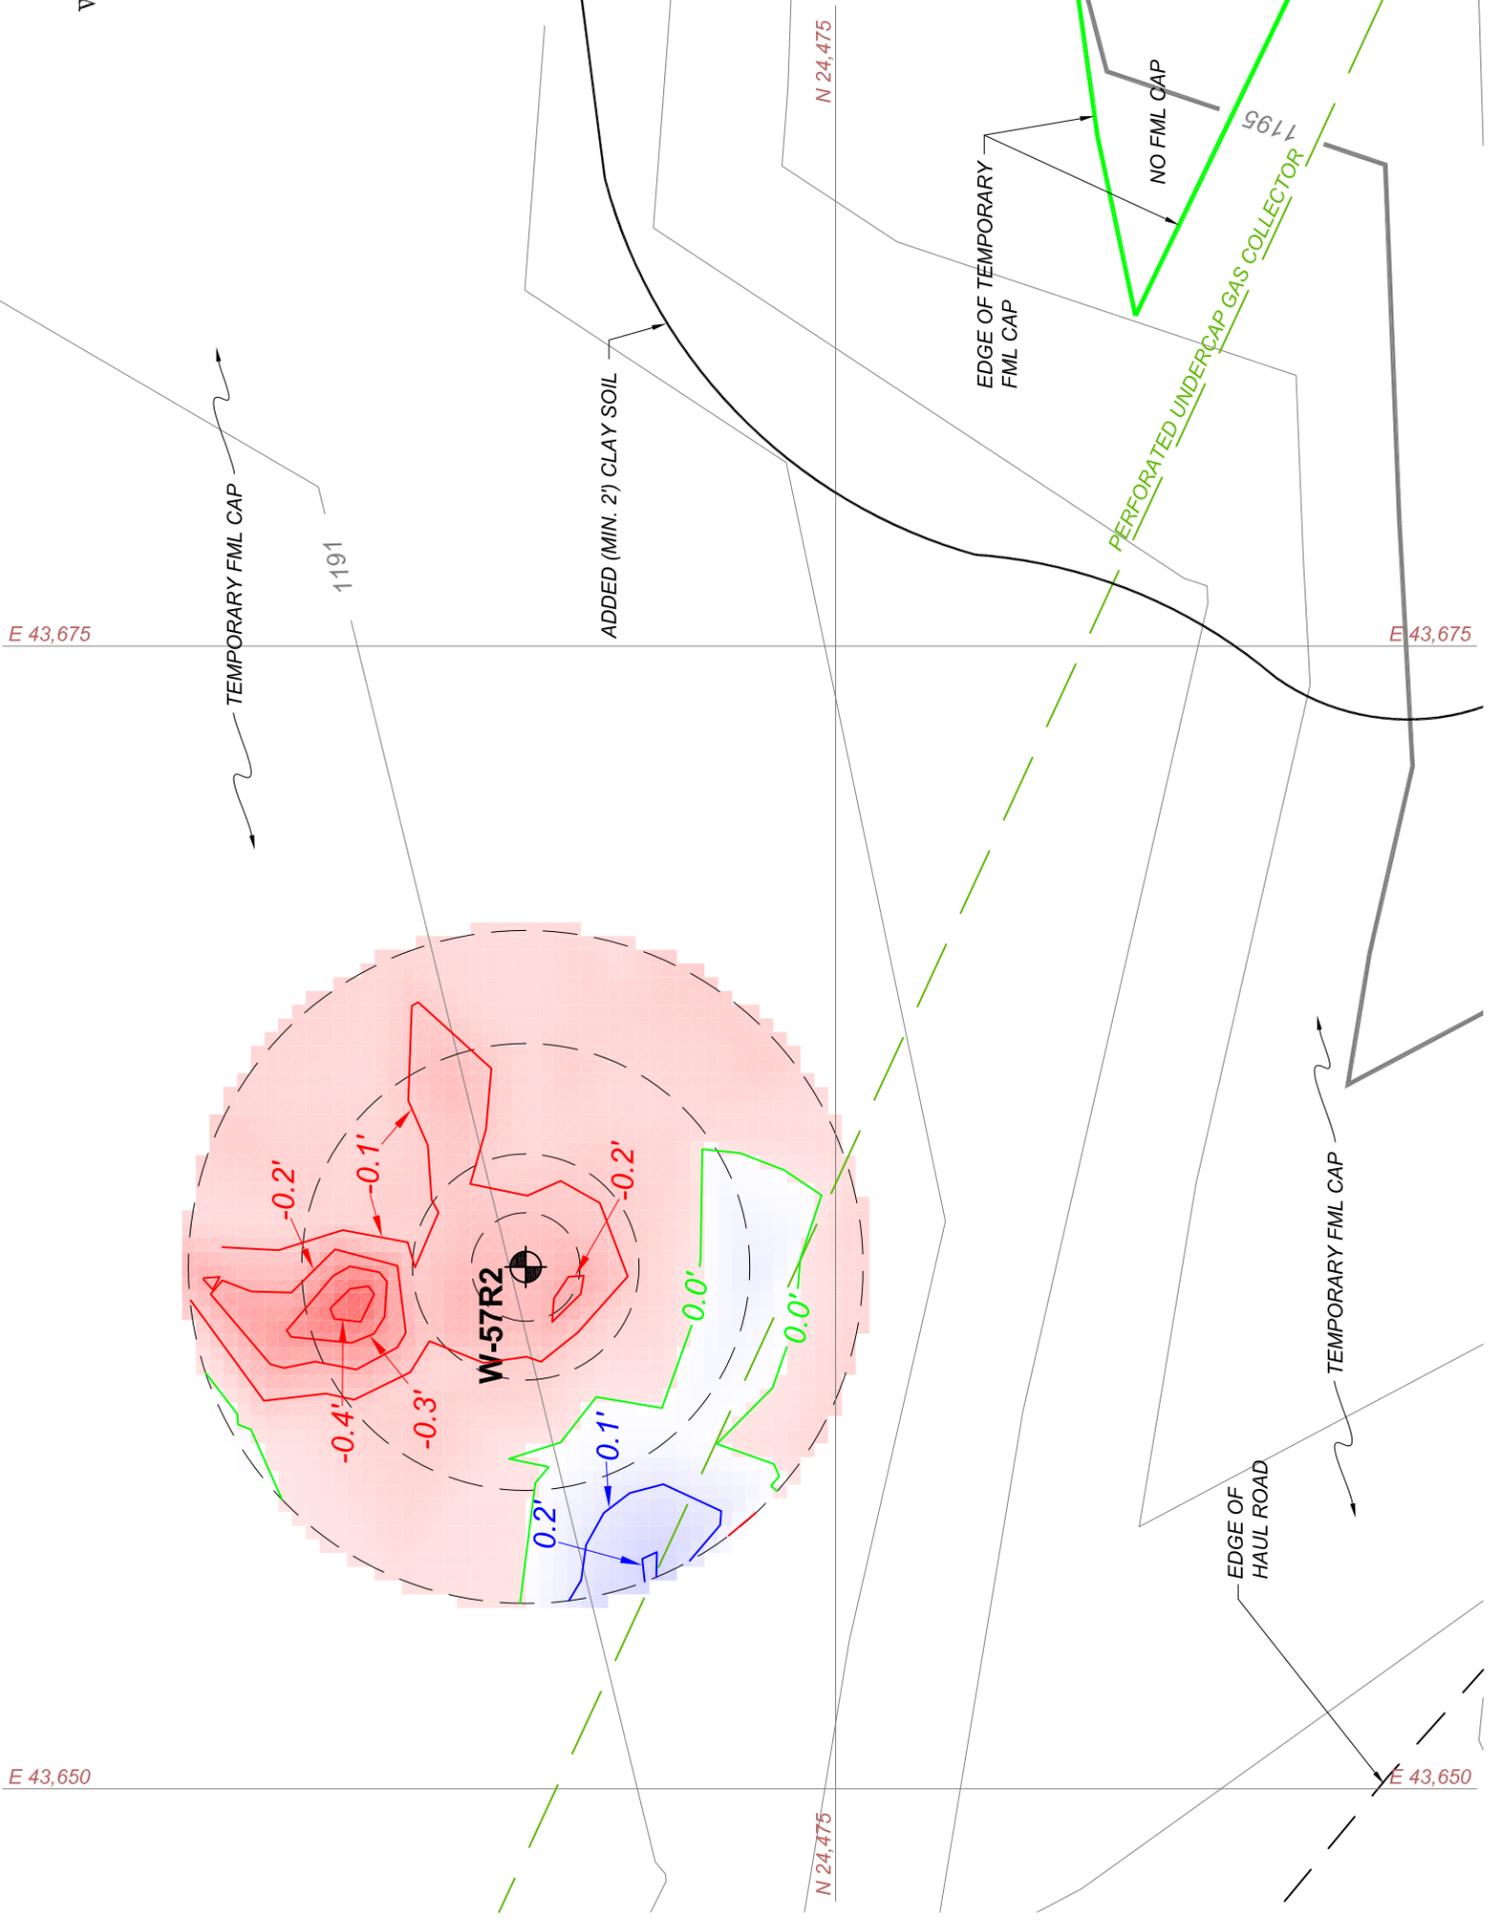
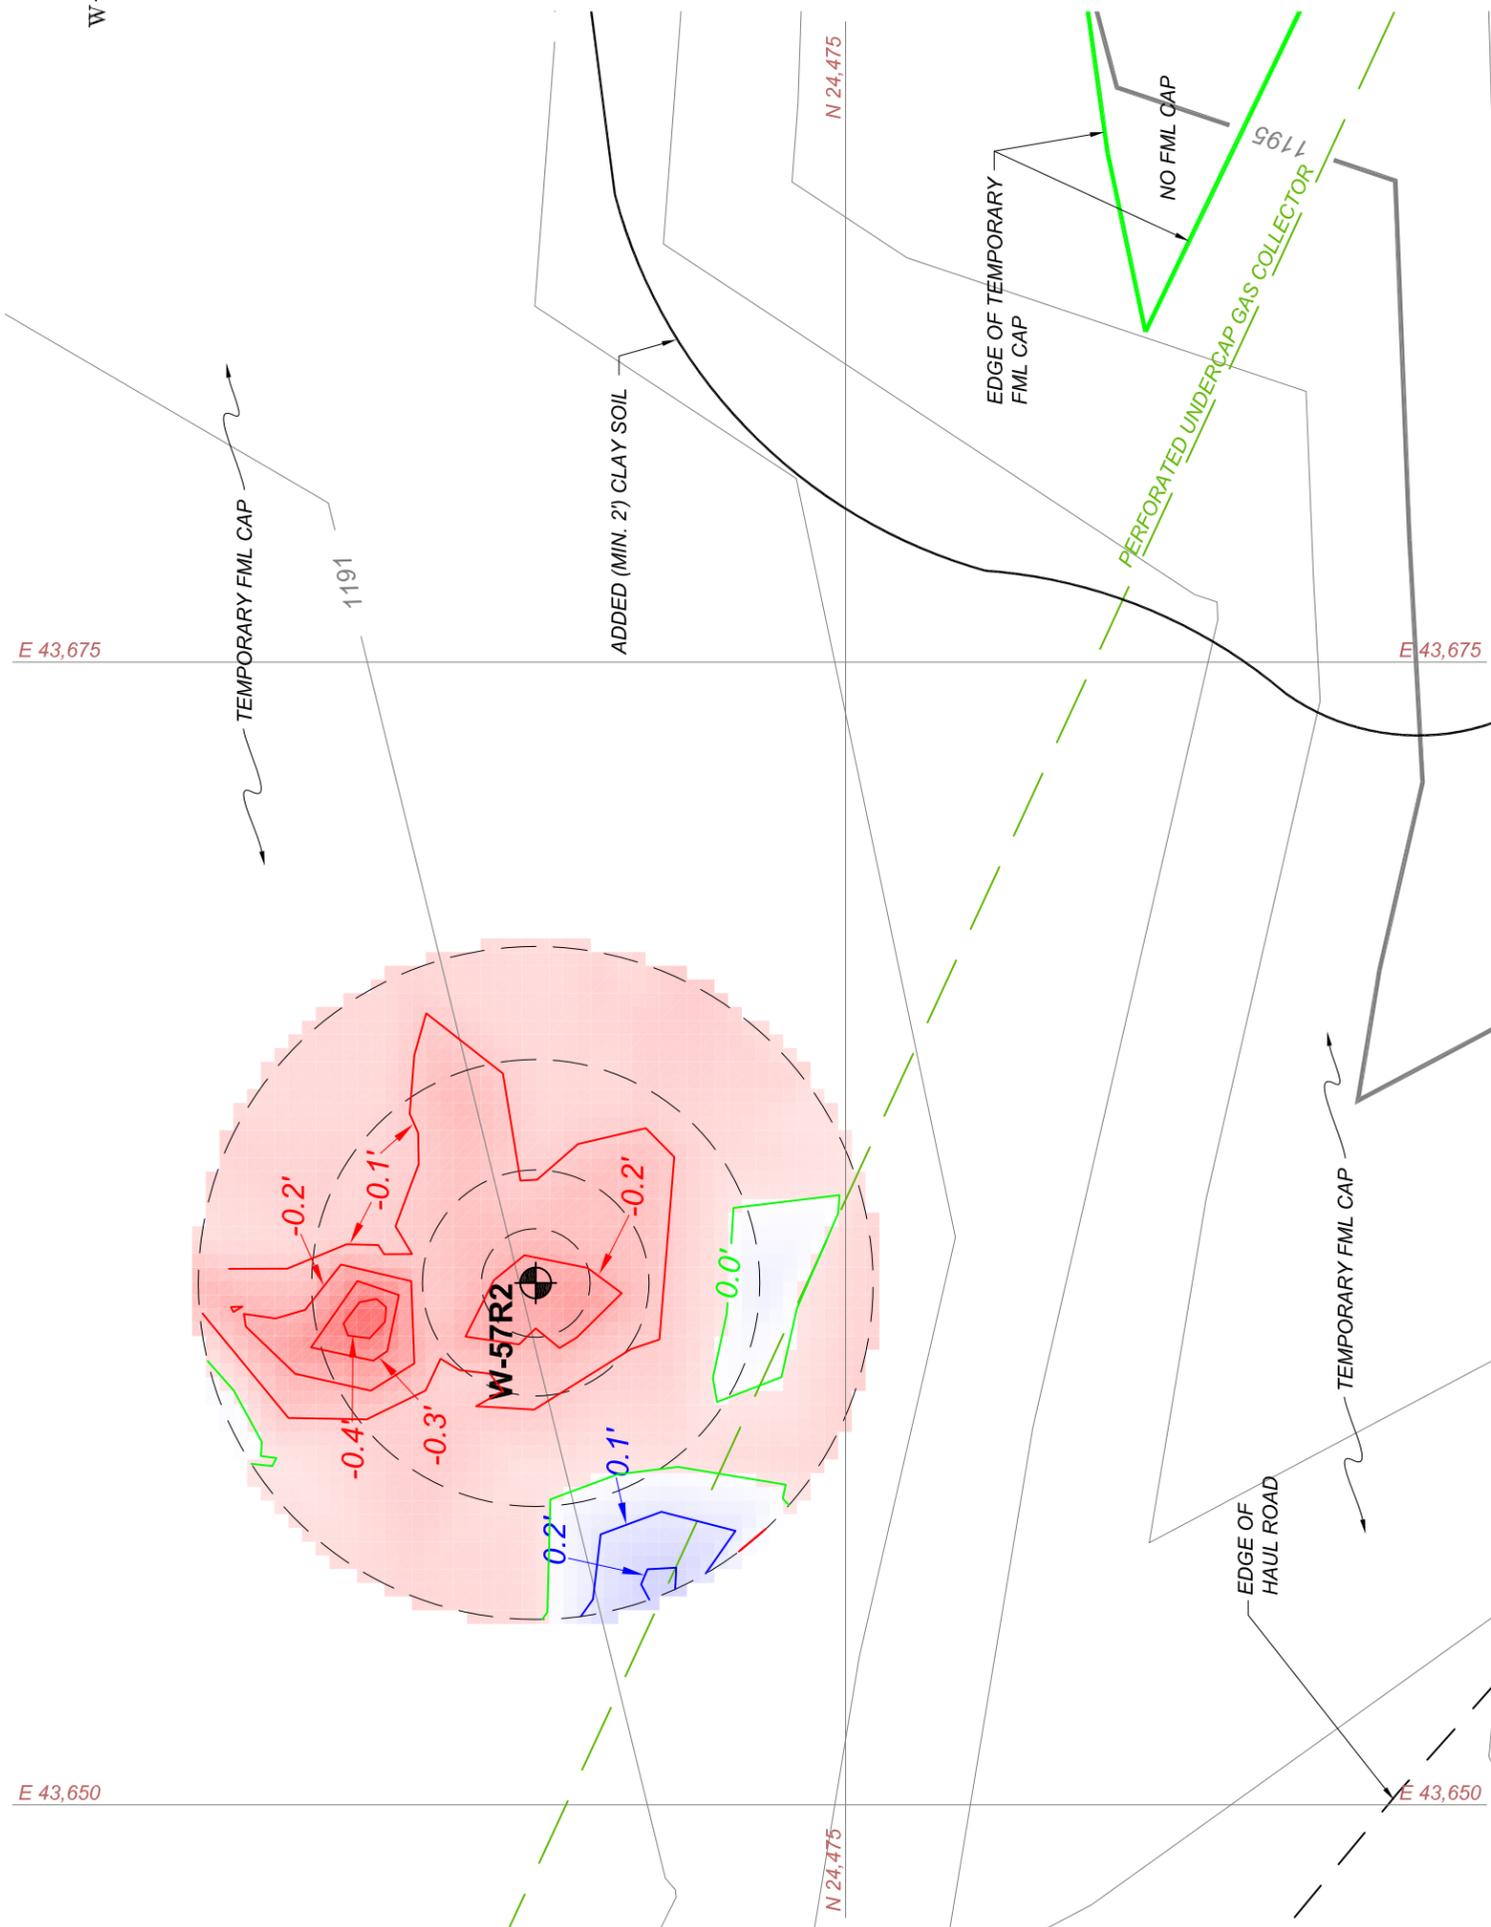
Attachment F – Local Settlement Survey Results

4. Weekly settlement surveys are being conducted and evaluated. The cumulative settlement to date is shown in Attachment F. Settlement less than 0.2 feet may be due to foot traffic or other local surficial disturbances. Those greater than 0.2 feet could indicate consumption of material under the ground surface and should be watched as a possible indicator of local subsurface fire. Examination of Attachment F suggests that some settlement occurred within the first week of monitoring but little to no settlement has occurred since then. The settlement data indicates no active underground material consumption is occurring due to fire.
