## Dura Avenue Landfill – Toledo

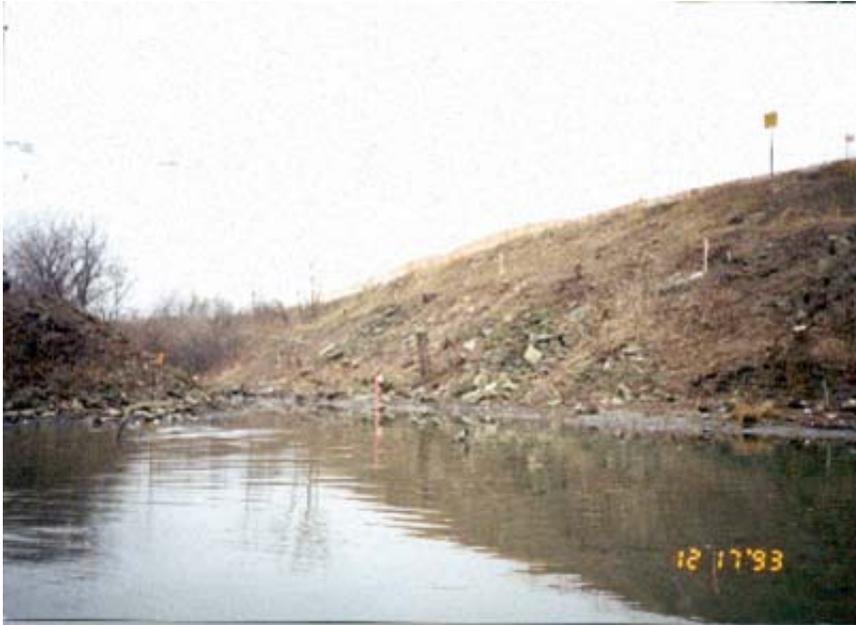
Pre-remedial photo of Dura Avenue Landfill, on the bank of the Ottawa River, where exposed refuse was draining hazardous chemicals into the river.

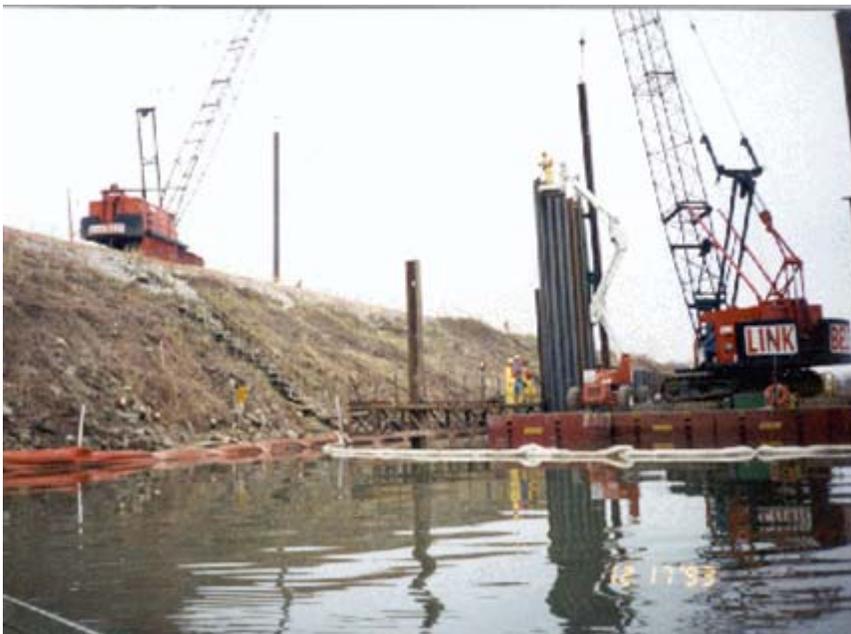
Installation of barrier wall along the Ottawa River bank.

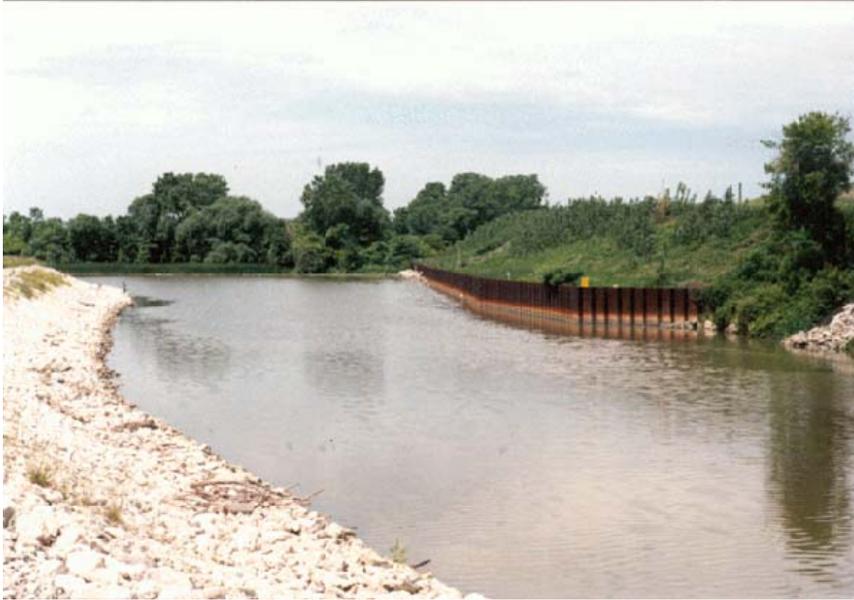
Completed barrier wall.

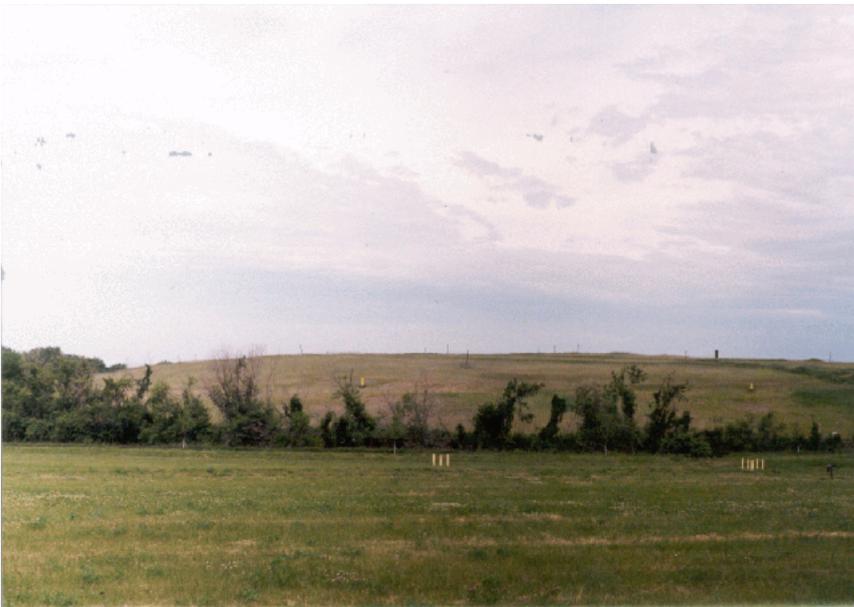
Main body of Dura Avenue Landfill after capping.
