# Unico Landfill Site Assessment Report

SITE ASSESSMENT REPORT

Unico Landfill  
Union County  
Project Number 180000830001  
OHD082747379

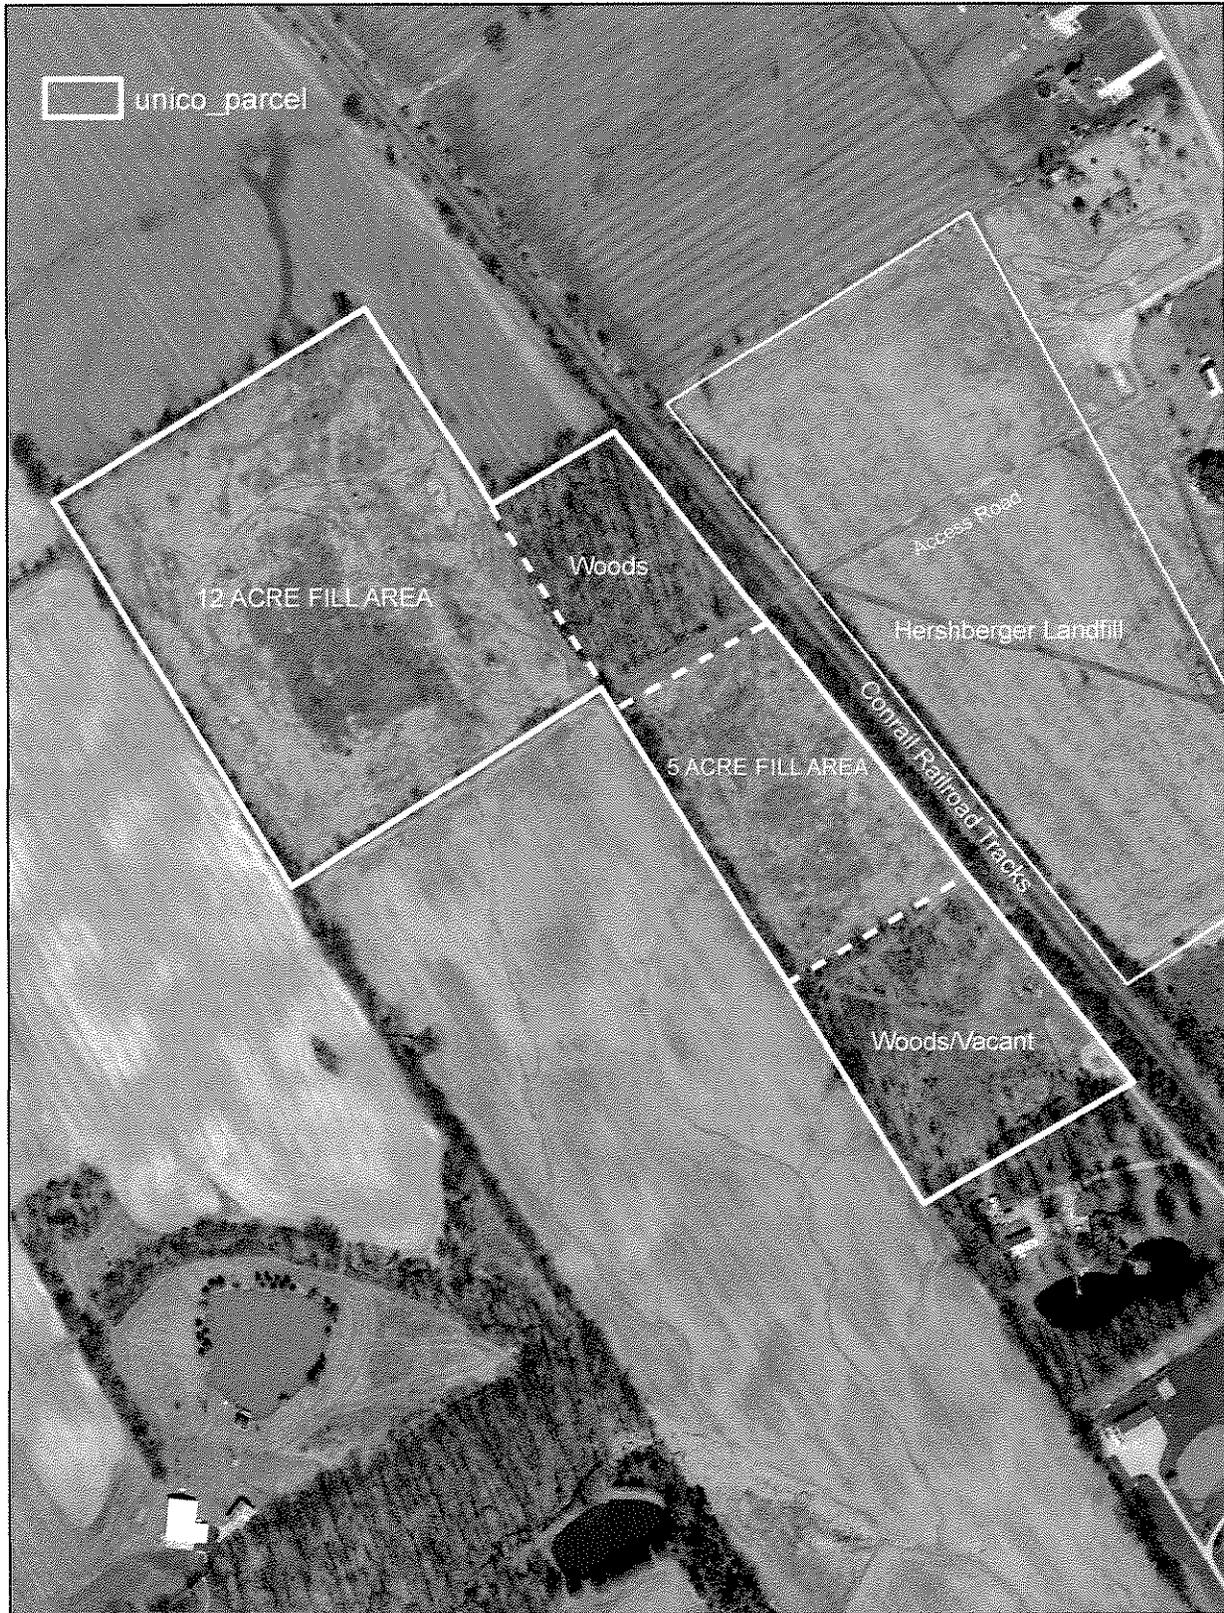
Figure 2  
 Site Features  
 Unico Landfill Site Assessment

Unico LF is located in Jerome Township in southern Union County (**Figure 1**). It is bordered by a CSX railroad line and farm fields. The total disposal area is 17 acres, which consists of a 5-acre disposal area and a 12-acre disposal area (**Figure 2**).

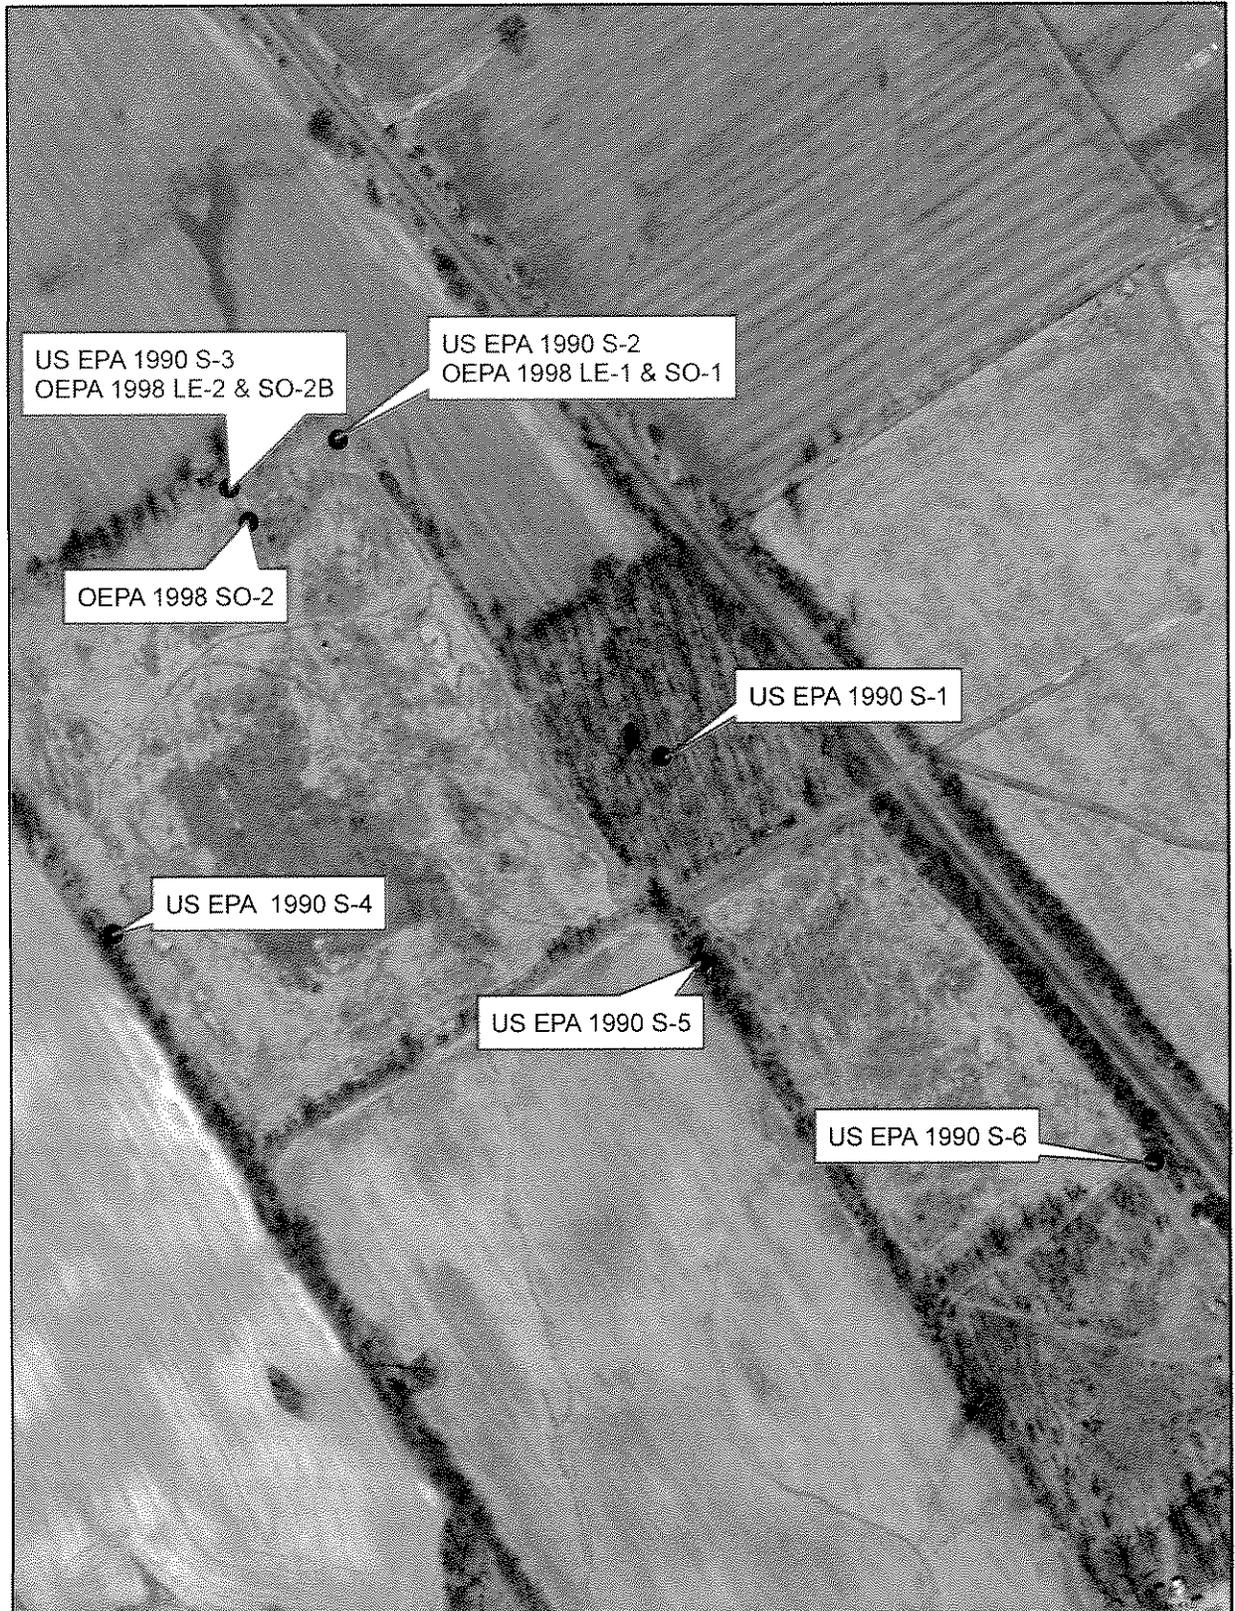
Figure 3  
Historic Sampling Locations  
Unico Landfill Site Assessment

In June 1998, Ohio EPA-DERR collected soil and leachate samples at observed seeps at the northeast end of the 12-acre disposal area (**Figure 3**). The samples were analyzed by Quanterra, the Ohio EPA contract laboratory. Analytes detected included volatile organic compounds (VOCs), semi-volatile organic compounds (SVOCs), and dicamba, a common herbicide (**Table 2**). Analyte concentrations in soil were compared to U.S. EPA Region 9 s PRGs for residential land use. Vinyl chloride and arsenic were the only analytes that exceeded the soil PRGs. The concentration of vinyl chloride was 0.3 mg/kg at Sample Location UNSO-1, which exceeded the PRG at the time of 0.079 mg/kg (the current PRG for vinyl chloride is 0.06 mg/kg). Although the arsenic concentration exceeded the PRG, the concentration is within the expected background level for Ohio.

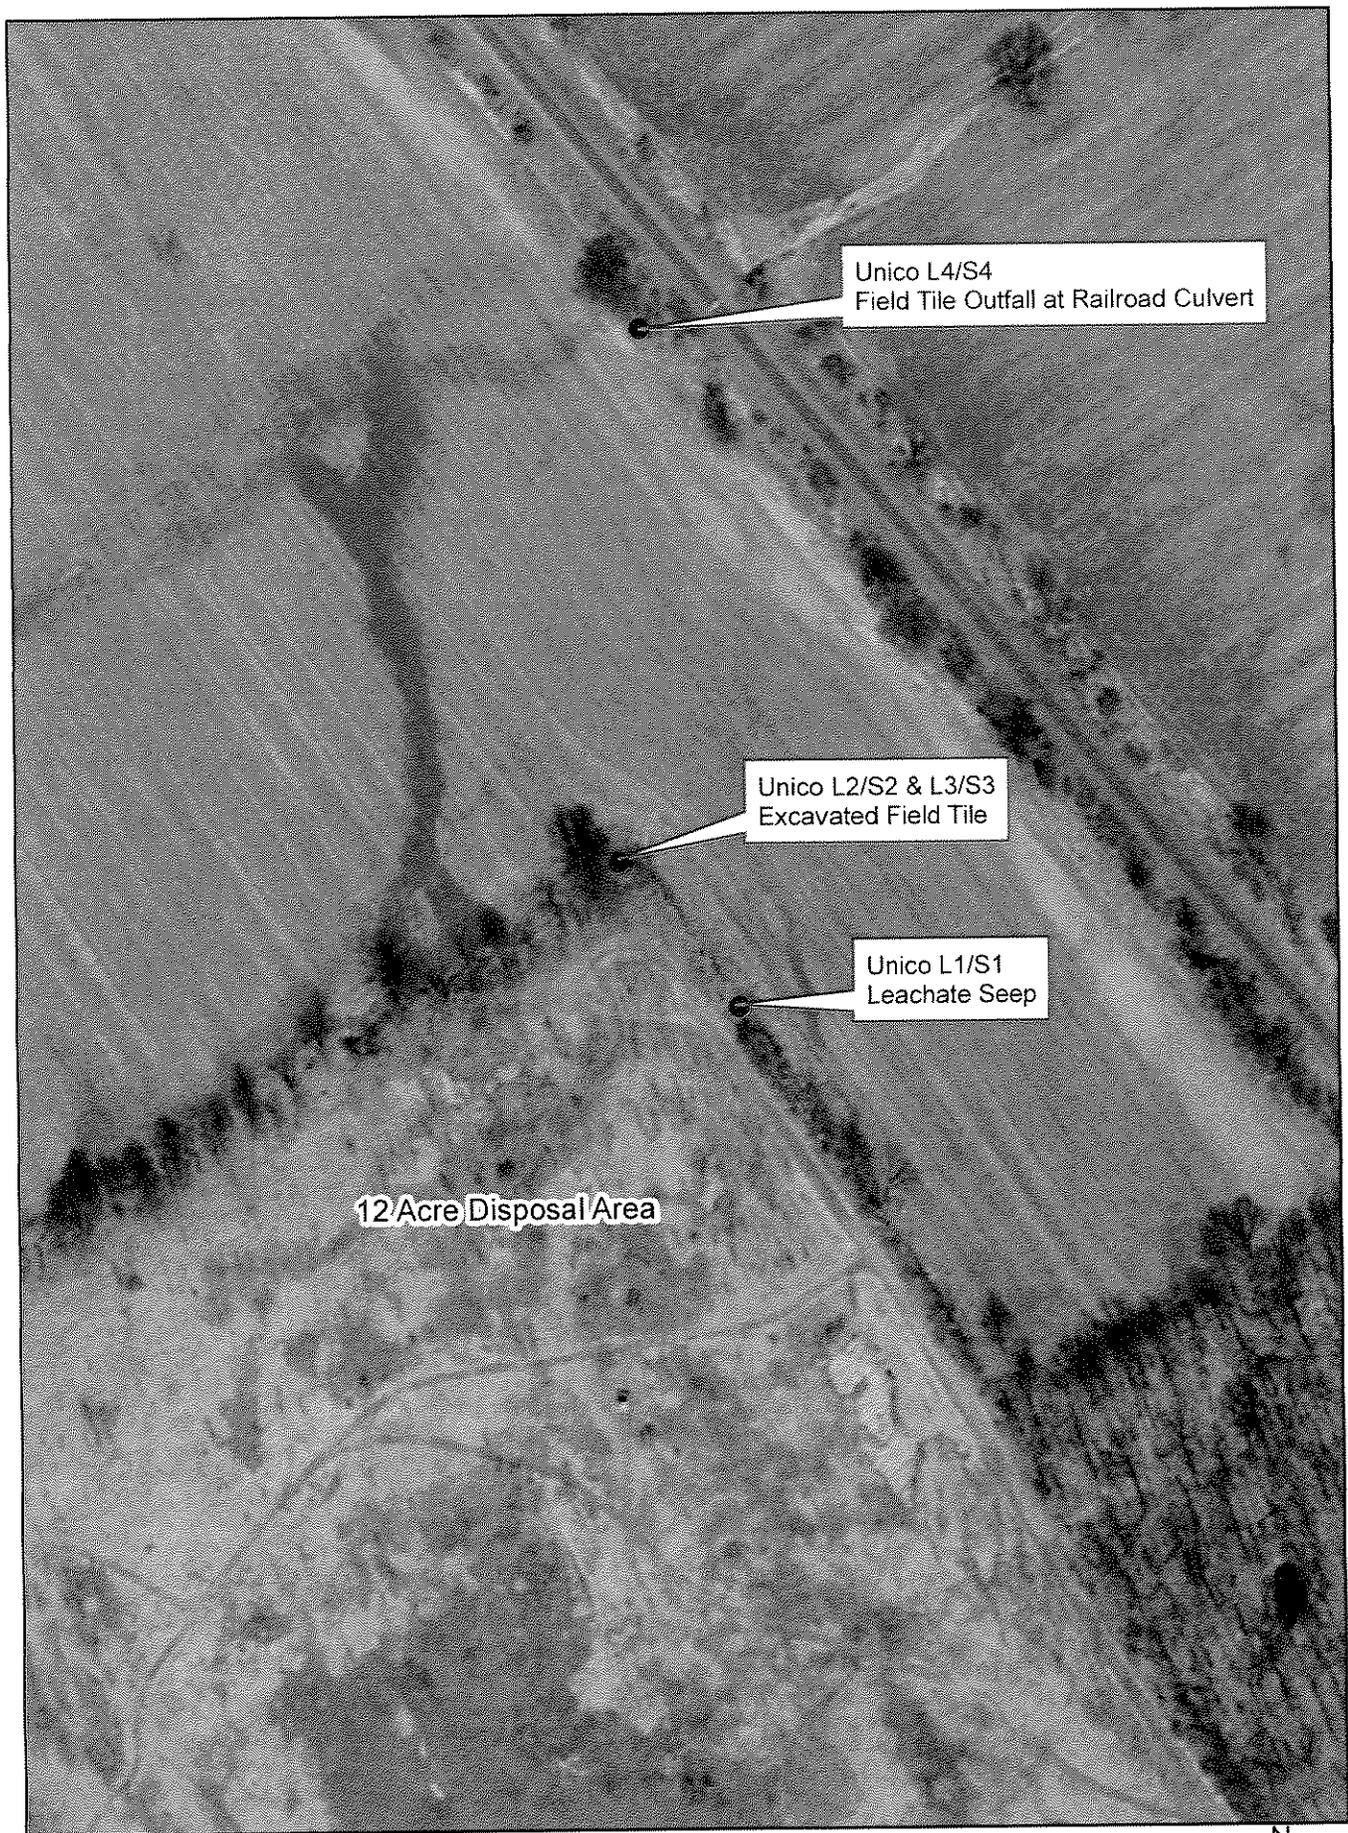
Figure 6  
Unico Landfill Site Assessment  
May 6, 2009 Sample Locations

The first sample location, L1, was collected at an active leachate seep for VOCs and metals analysis. Samples were collected by bottle immersion. The acid preservative in the 40 ml VOC vials reacted with the leachate causing effervescence. Attempts to clean the acid out of the vials were not entirely successful, therefore, small bubbles formed in the vials. This factor was noted on the chain-of-custody form, and the sample was analyzed within seven days of receipt. A photo-ionization detector (PID) reading of 0.0 PPM was obtained at the seep. The pH of the leachate was 7.70, the temperature was 11.0°C and the conductivity was out of range (>1999 ugS). A soil sample was collected in conjunction with this leachate sample, designated S1, using a scoop, and analyzed for VOCs, SVOCs, PCBs/pesticides and metals.

The second leachate sample location, L2, was sampled for VOCs, SVOCs, PCBs/pesticides, metals and cyanides. Samples were collected by bottle immersion where the leachate entered the field tile. Again, the leachate reacted with the acid preservative in the VOC vials causing effervescence. This factor was noted on the

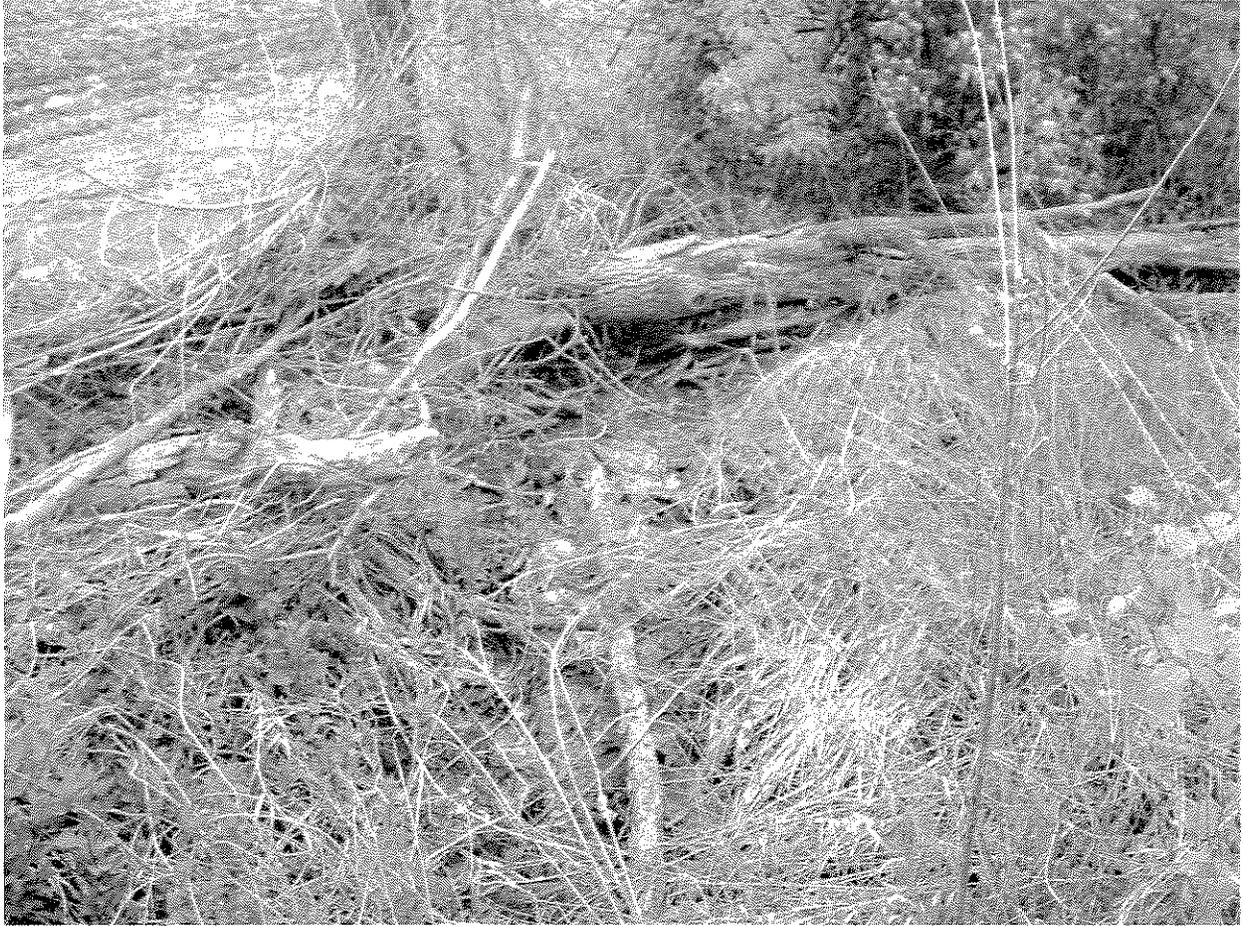
**Figure 1: Unico LF 5-6-09. First leachate outbreak, 200 feet from northeast corner of landfill.**

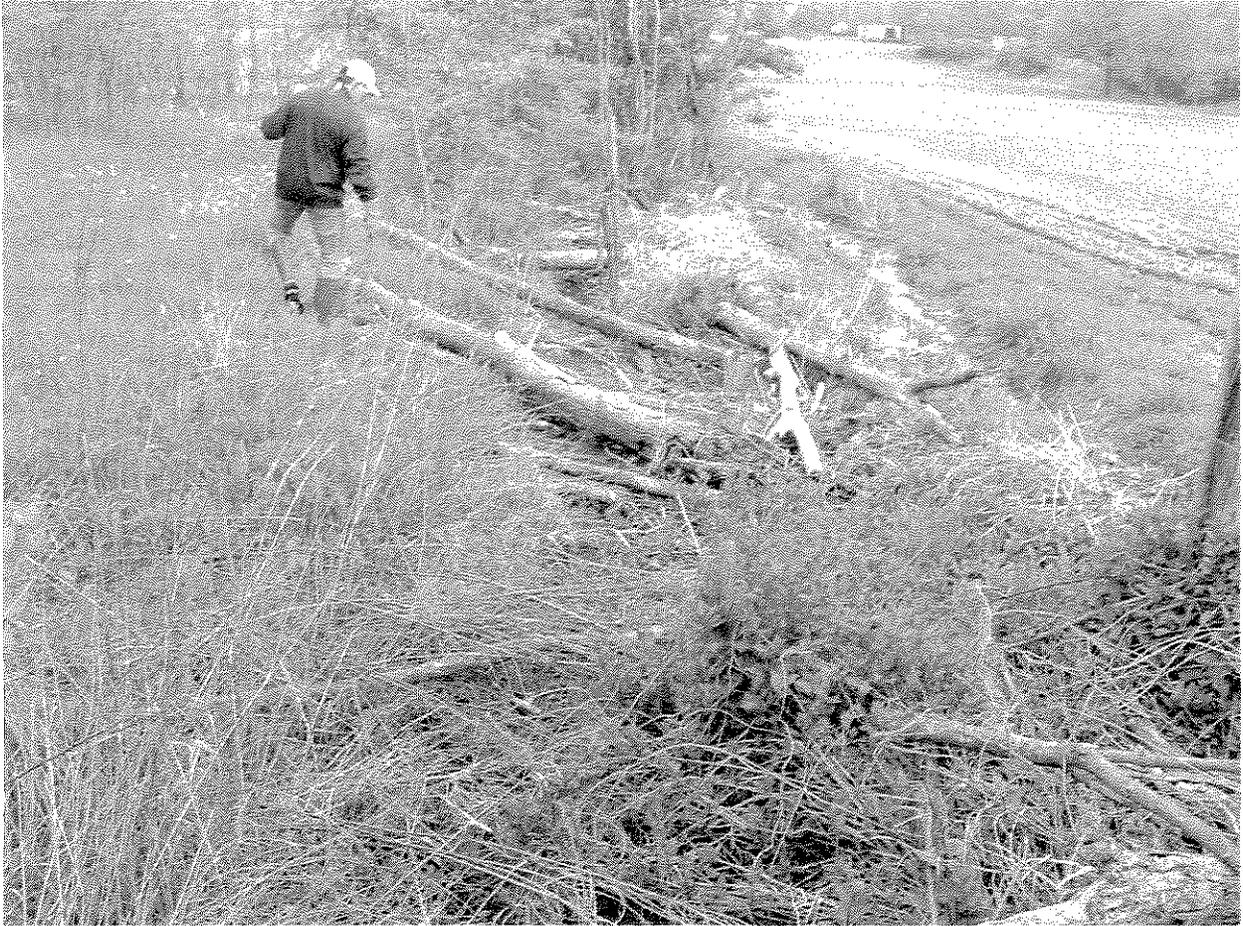
**Figure 2: Unico LF 5-6-09. Looking north at northeast edge of the landfill. Note ditch adjacent to farm field to divert leachate to the north.**

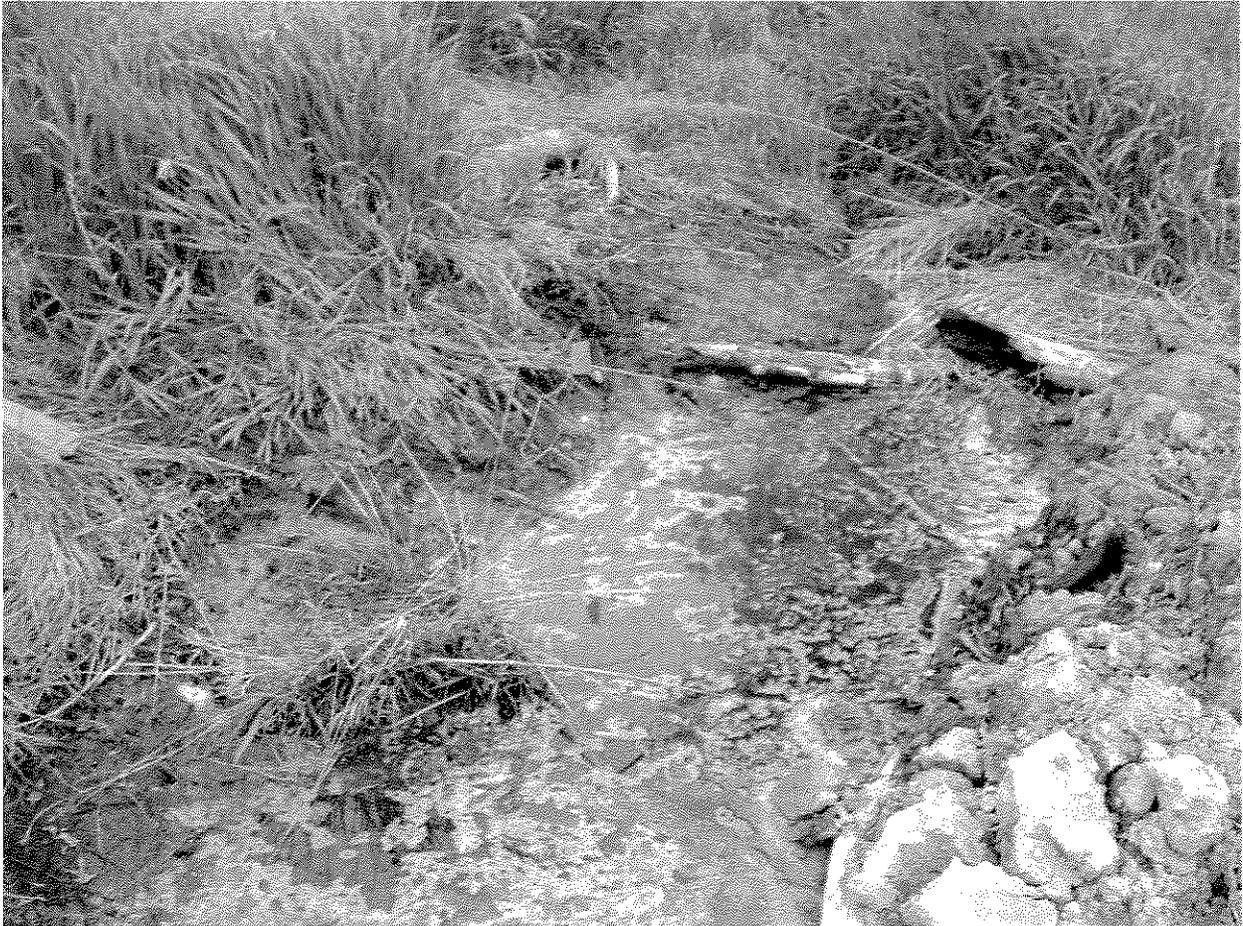
**Figure 3: Unico LF 5-6-09. Sample located L1/S1.**

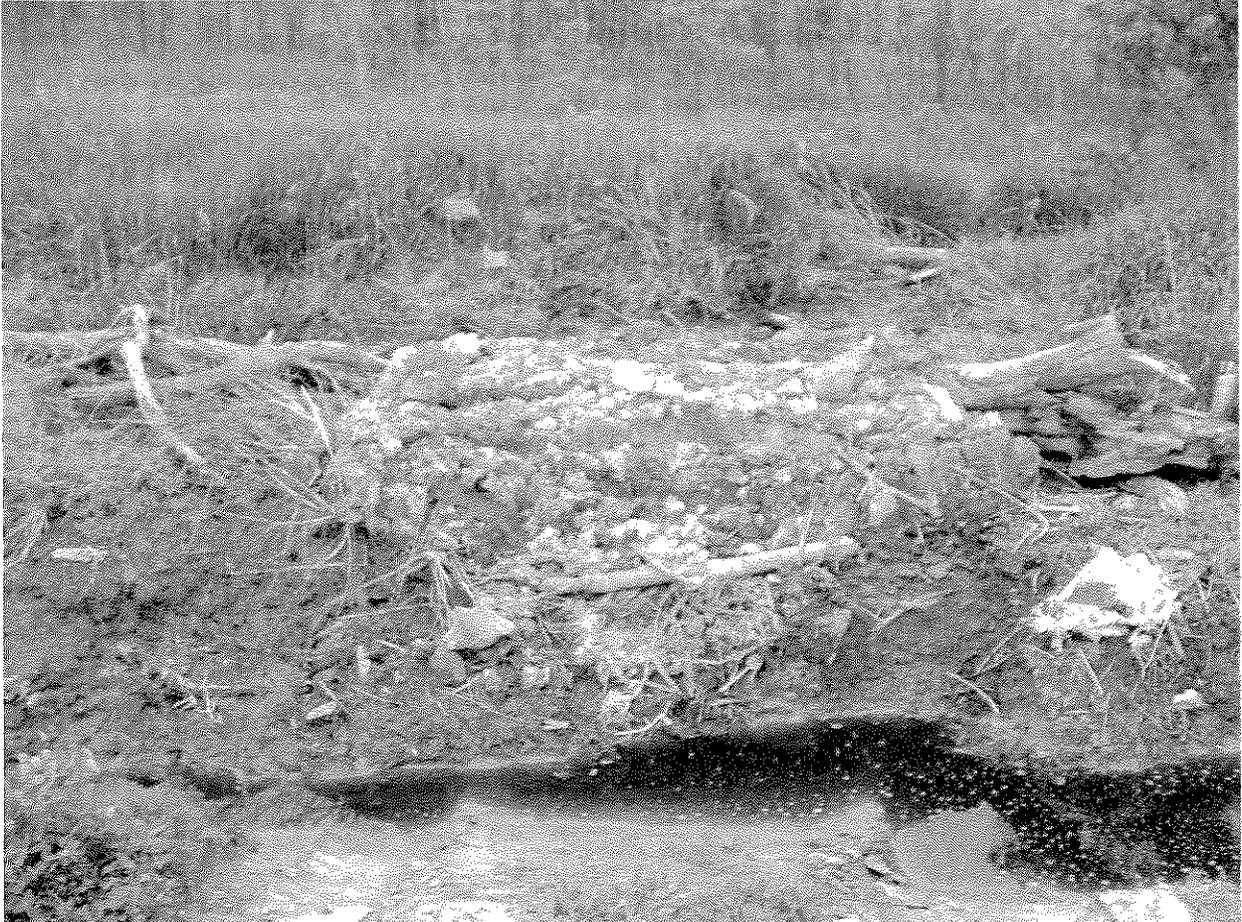
Figure 4: Unico LF 5-6-09. Looking West at sample location L1/S1. Leachate pooled in constructed ditch below the

seep.

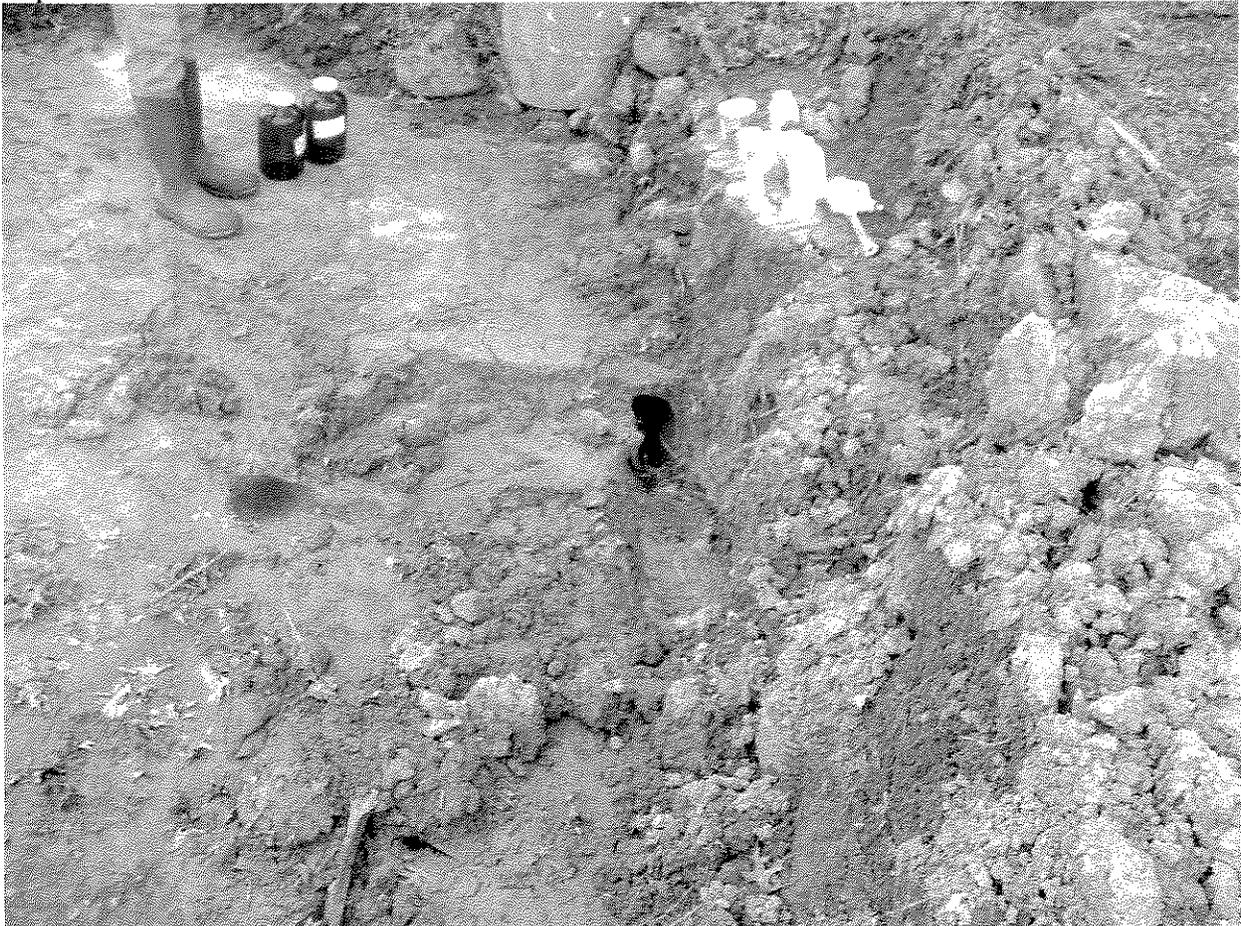
I noted that the plastic barrel at the northeast corner had been recently excavated and clay drain tiles were exposed. The leachate was flowing into the broken 4" field tile, which trended south from Unico to the north toward the swale in the adjacent farm field. The flow was to the north toward the swale in the farm field. Robin and I attempted to find field tile outfalls at the swale, but there was no flowing water in the swale and no exposed field tiles. We followed the swale to the east to the railroad tracks and found the end of a perforated plastic drainage pipe and clay field tile at the railroad culvert. I decided to change the sampling plan and sample the water and sediment at the railroad culvert.

Figure 5: Unico LF 5-6-09. Looking south at sample location L2/S2 and L3/S3. Clay field tile is broken and trends south-north along the landfill. Water flows to the north (toward camera).

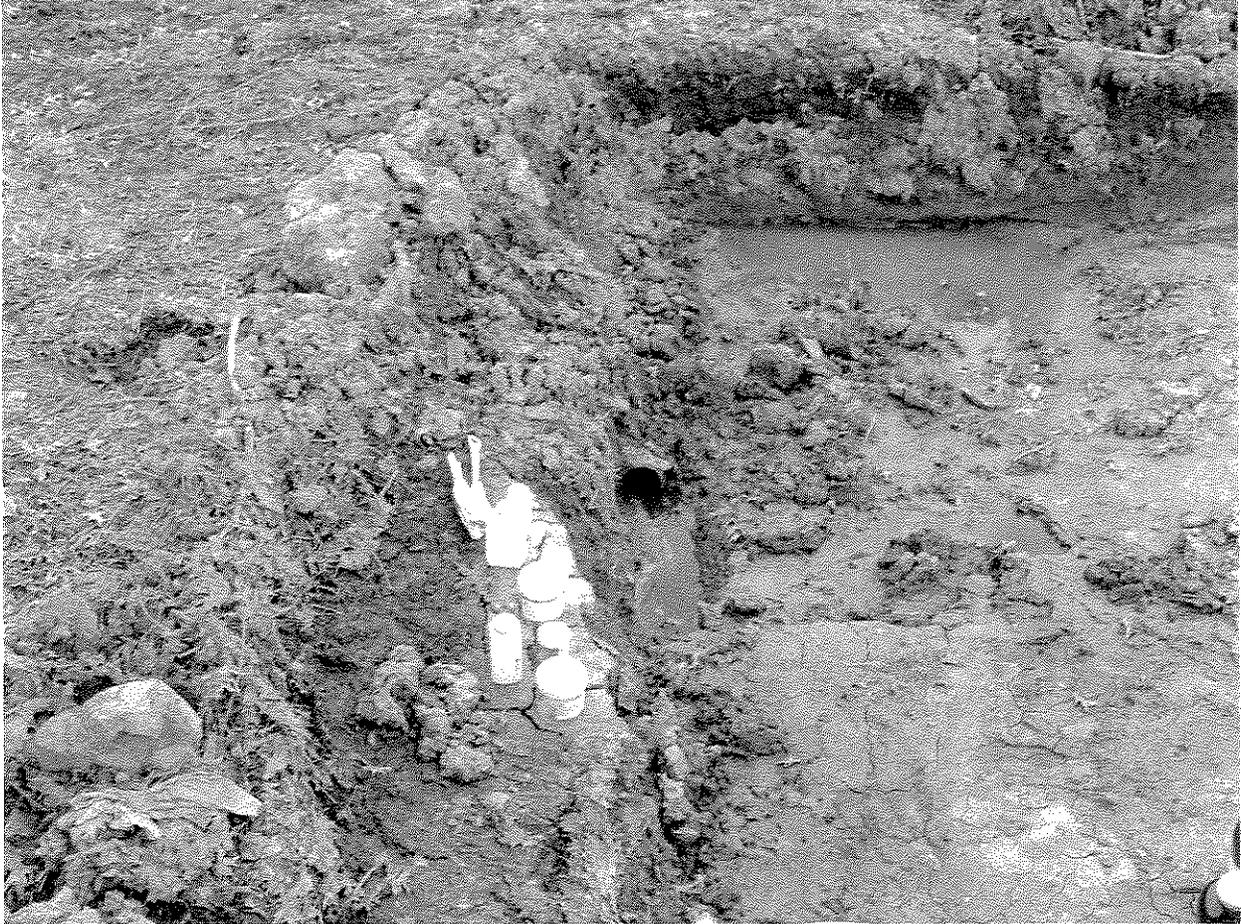
**Figure 6: Unico LF 5-6-09. Looking north at sample location S2/L2 & S3/L3. Leachate flows from ditch into excavation and into drainage**

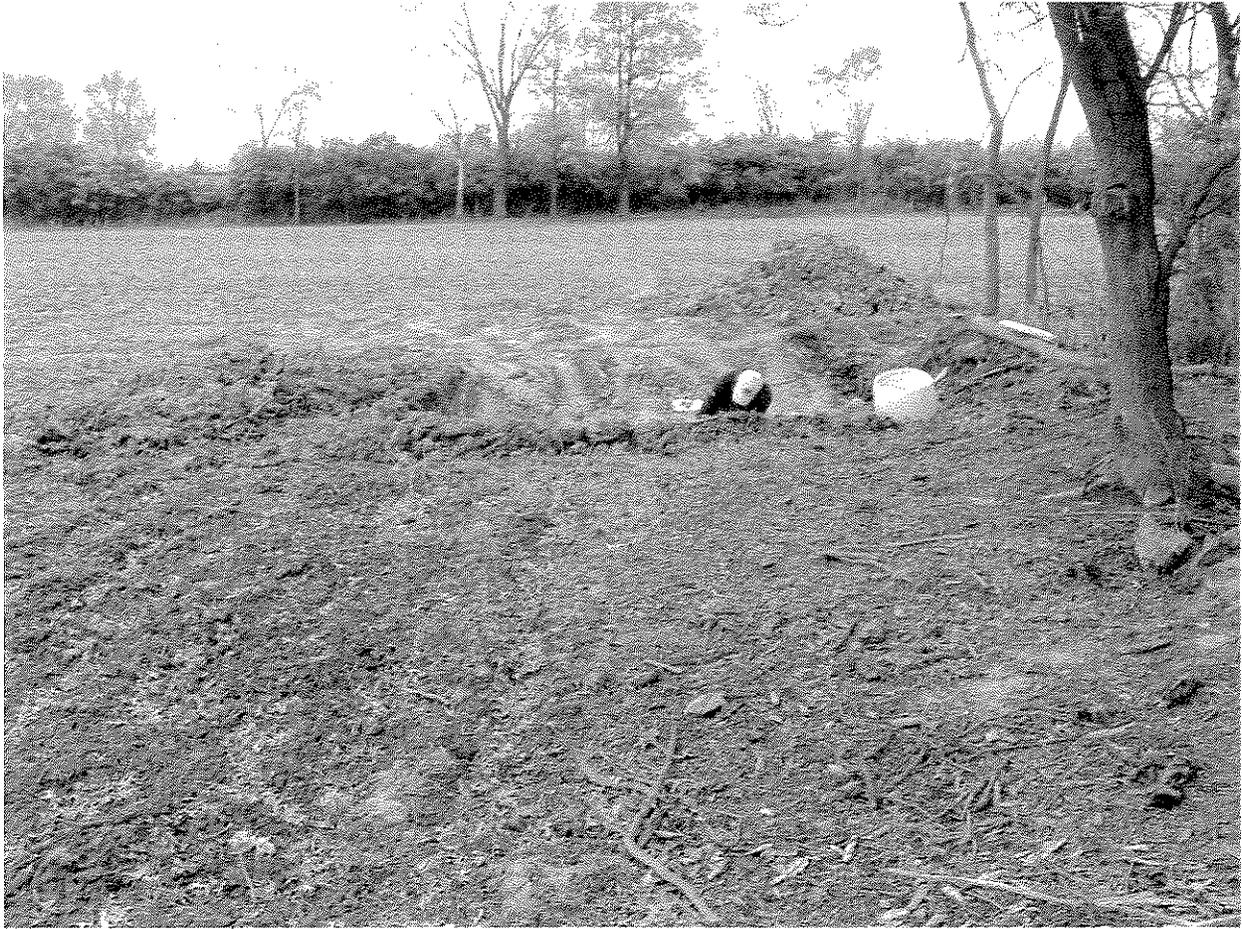
Figure 7: Unico LF 5-6-09. Looking east at sample location L2/S2 & L3/S3.

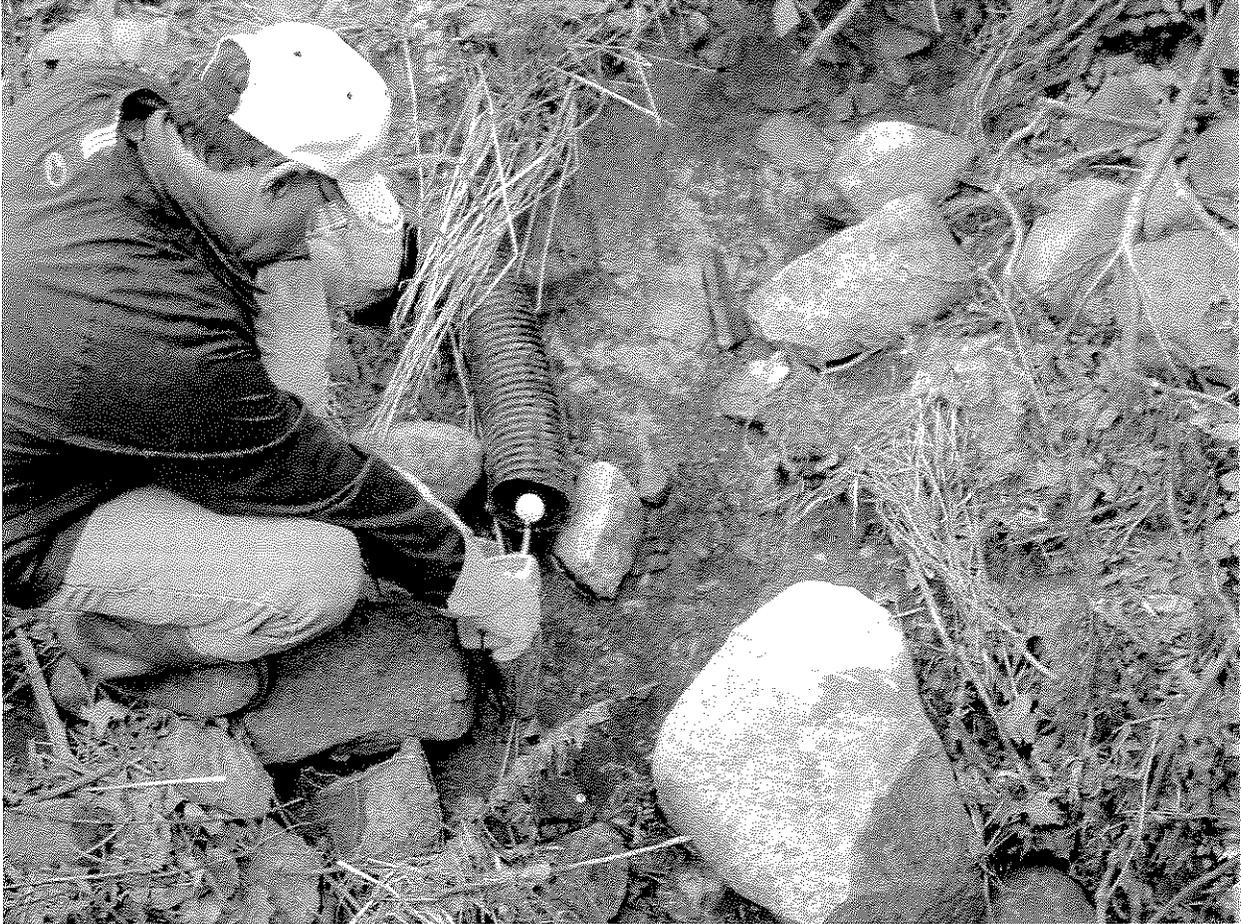
The final sample location (L4/S4) was collected at the railroad culvert downstream of the two drainage pipes. Samples were collected for VOC and metal analysis. Slag and other debris were noted at this location. PID reading of 0.3 ppm was measured in the plastic drainage pipe. Ms Welch observed sampling. *pH 8.04, Temp 10.3°C  
Cond. out of range.*

Figure 8: Unico LF 5-6-09. Sample location L4/S4. Perforated plastic pipe at railroad culvert.

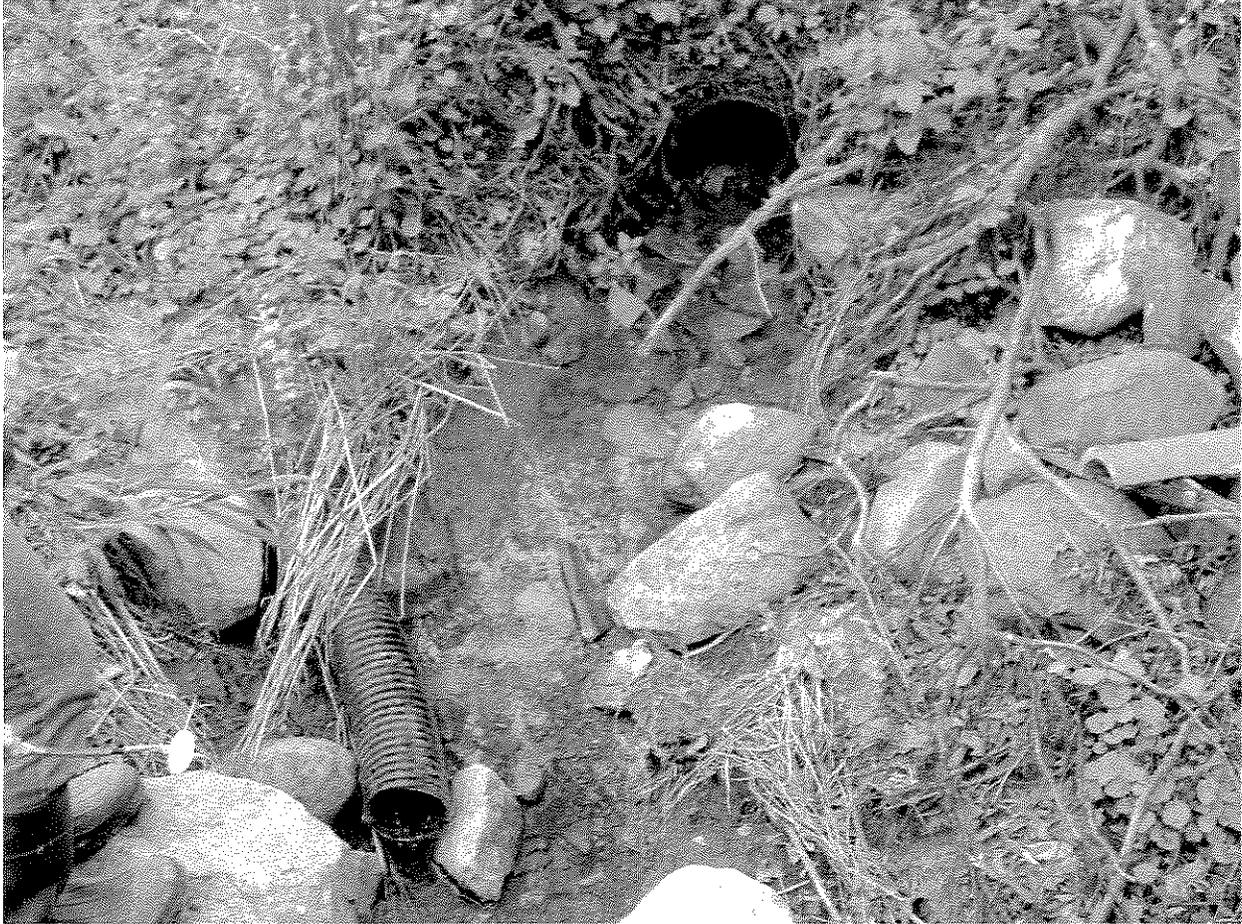
**Figure 9: Unico LF 5-6-09. Sample location L4/S4. Field tile and plastic pipe draining farm field to the west.**

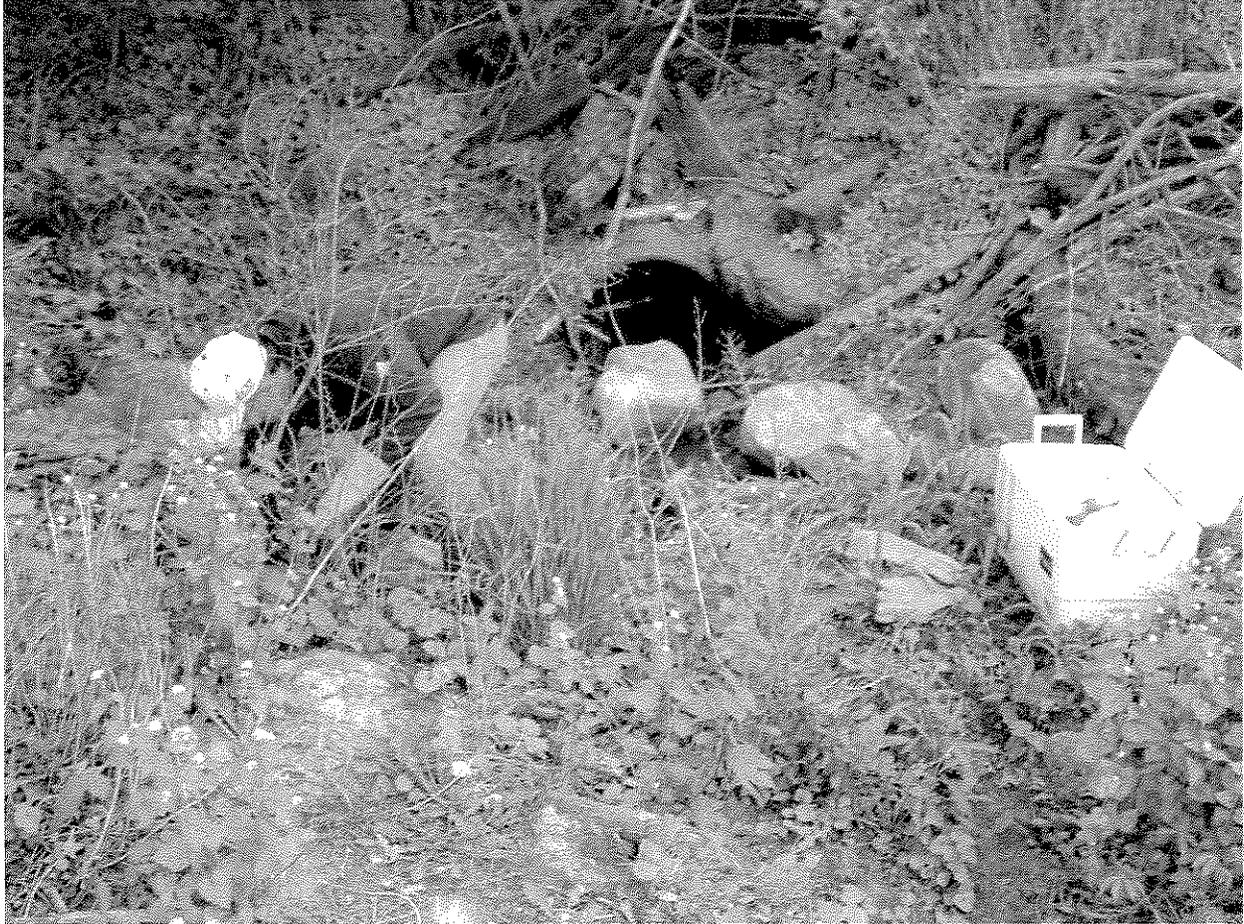
**Figure 10: Unico LF 5-6-09. Looking east at sample location L4/S4. Culvert that goes beneath the railroad tracks.**

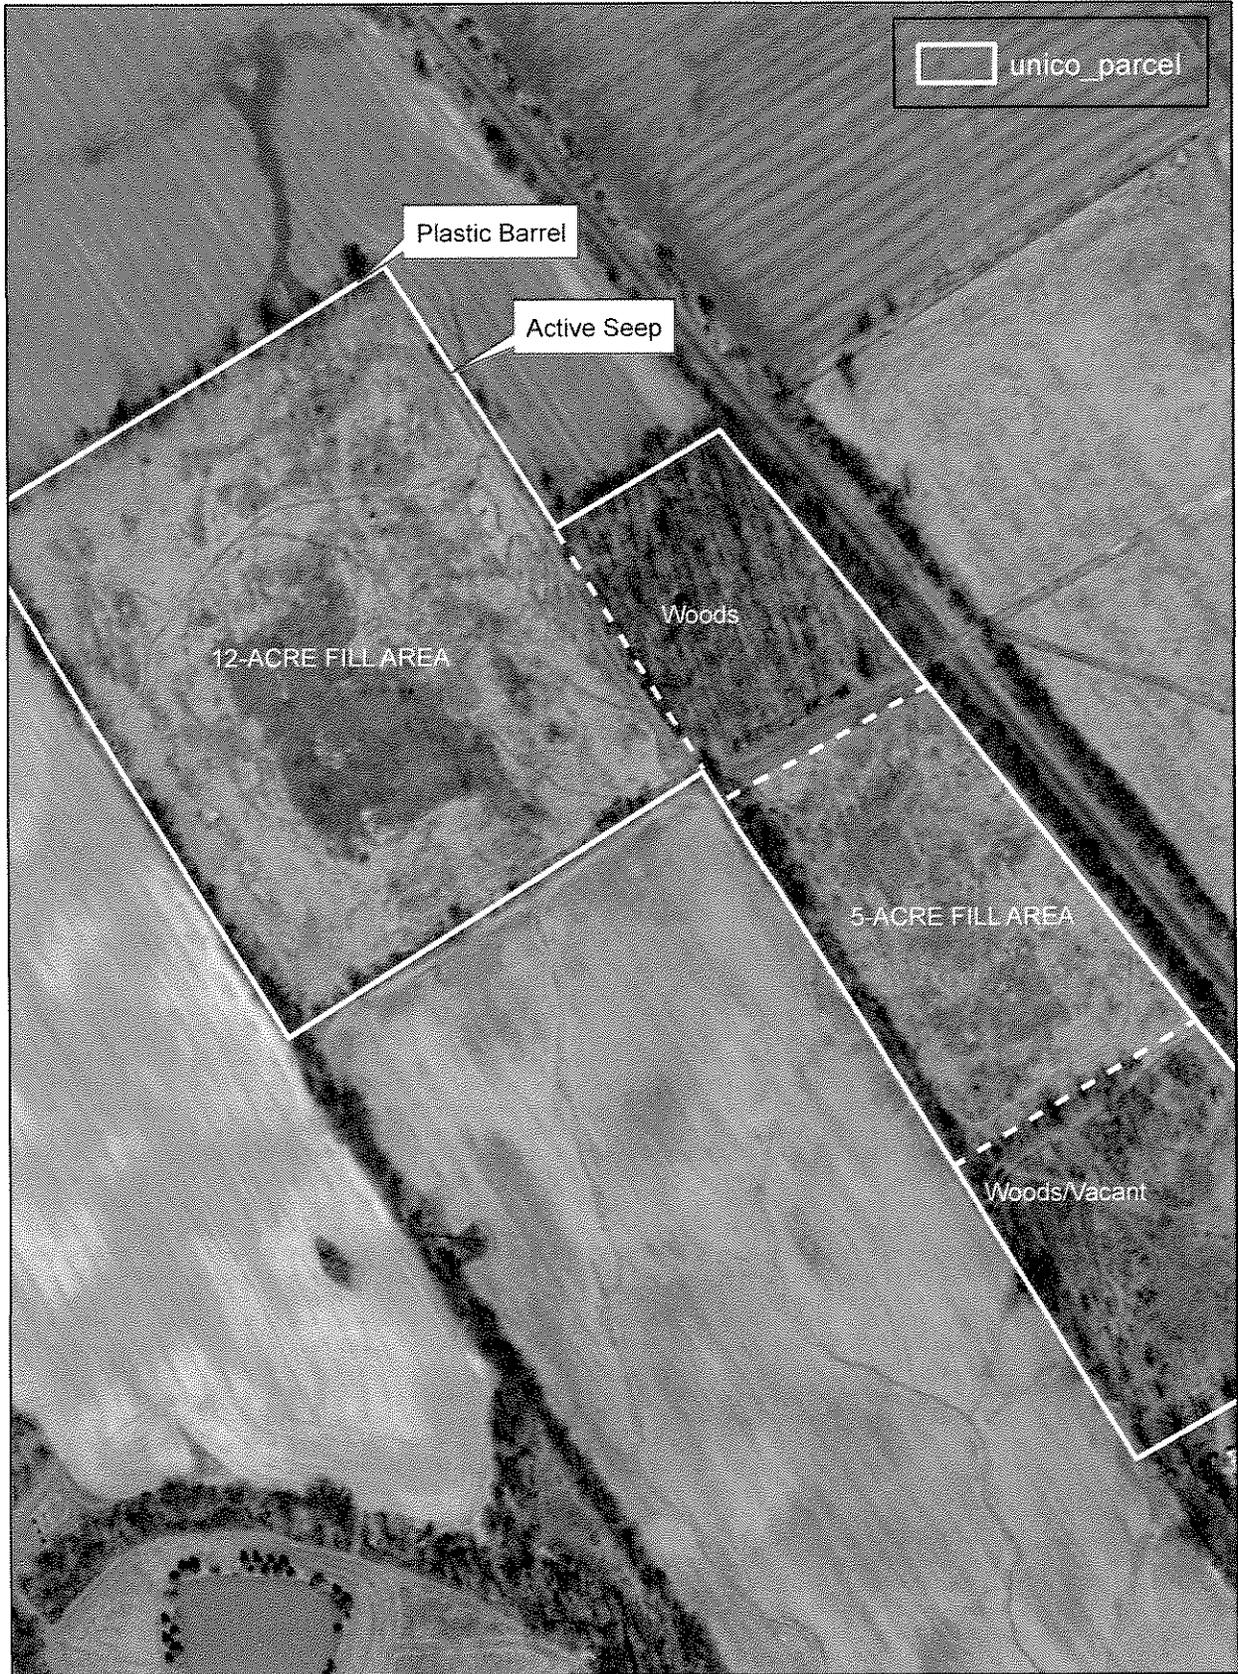
Figure 3  
Site Features  
Unico Landfill

Unico Landfill is located in Jerome Township in southern Union County. It is bordered by agricultural land and railroad tracks. The fill area consists of a 12-acre area and a 5-acre area (**Figure 1**). The estimated total volume of waste is 350,000 cubic yards. The waste consists of solid waste, industrial wastes, and hazardous wastes (as defined in ORC 3734.20). Industrial waste materials include electroplating sludge, industrial wastewater sludge, paint booth filter sludge, solvent cleaning sludge, fly ash, resins, asbestos, acids, and bases. The hazardous wastes were placed in trenches by permit and covered with solid waste.
