## Countywide Recycling & Disposal Facility

November 26, 2008

RE: Request for Information - W-57R  
Countywide Recycling and Disposal Facility, East Sparta, Ohio

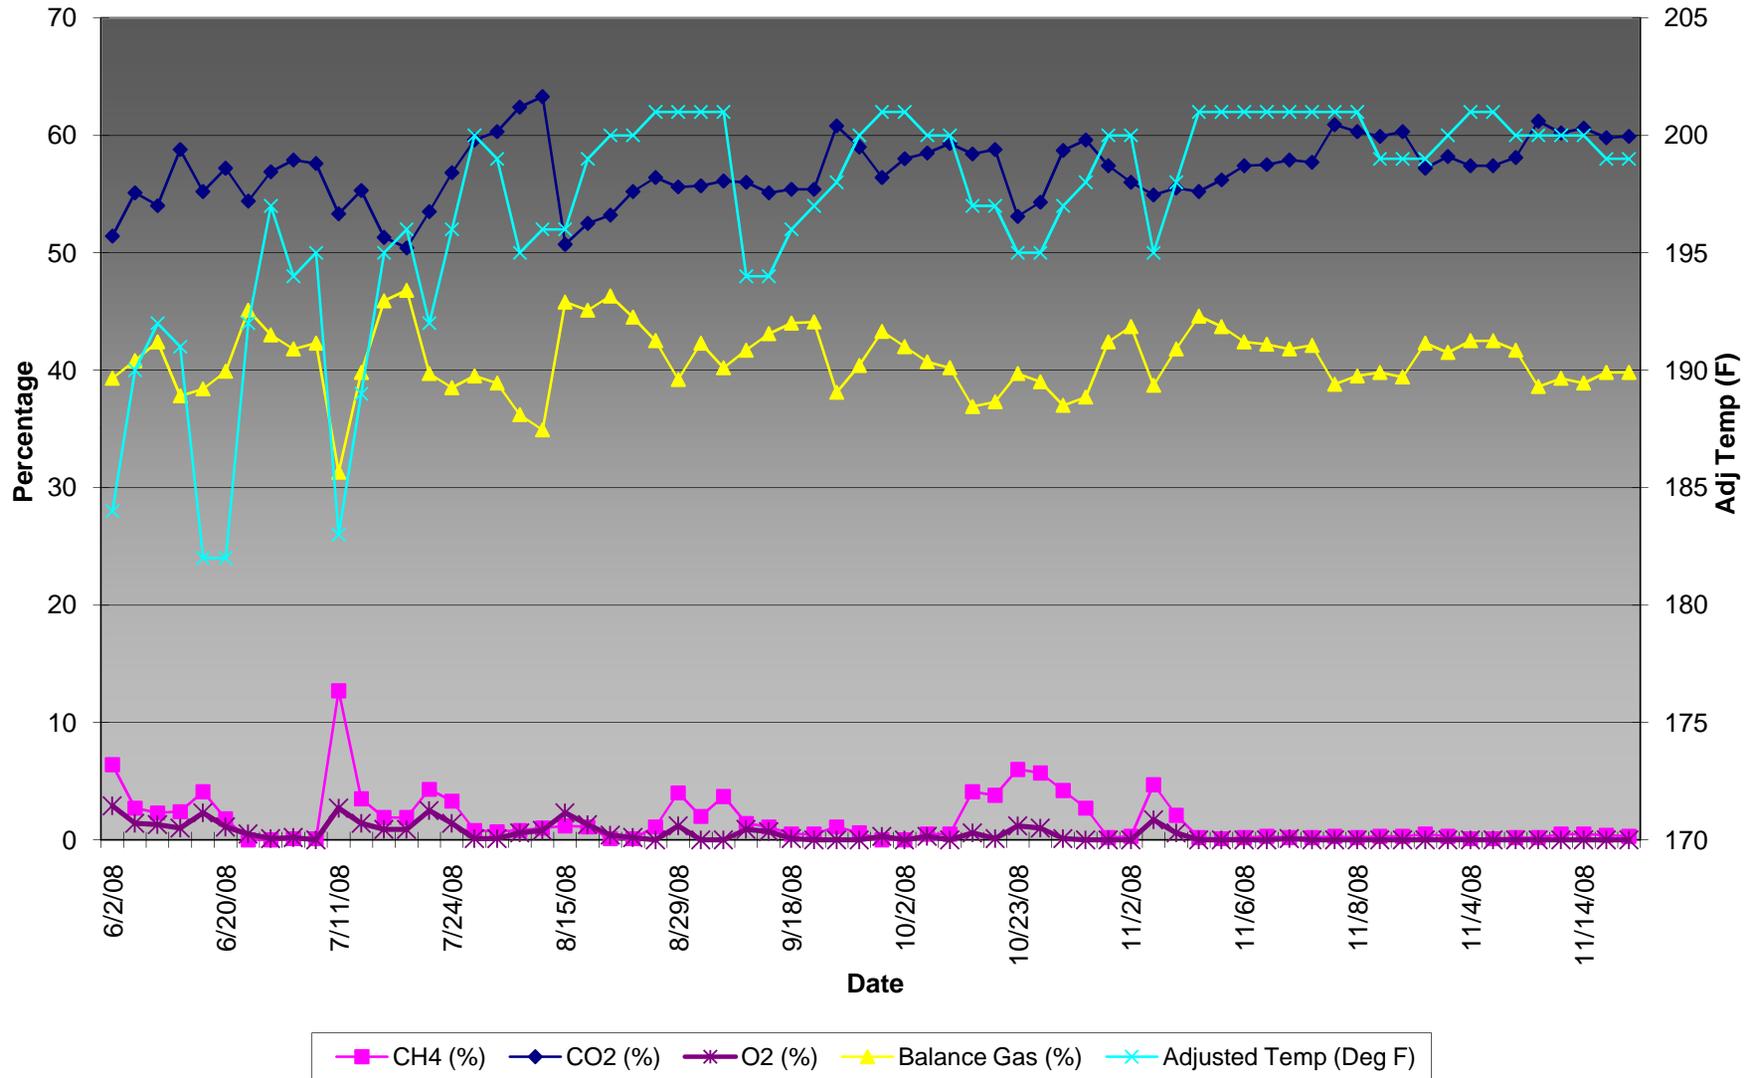
PW-57R

In July 2008, a pump failed in W-57R2 and blocked further access beyond about 12 feet deep (same depth as the warm pocket of dross); since that time, downhole access beyond 12 feet deep has not been possible and that is reflected on the downhole temperature plot provided in Attachment B.
